RISK MANAGEMENT SURVEY REPORT

Tshwane Automotive Special Economic Zone (TASEZ)

Samcor Park (Corner Propshaft Road, Alwyn Road) Safatanaga Road (Nelmapius X 27) Silverton, Gauteng

September 2023

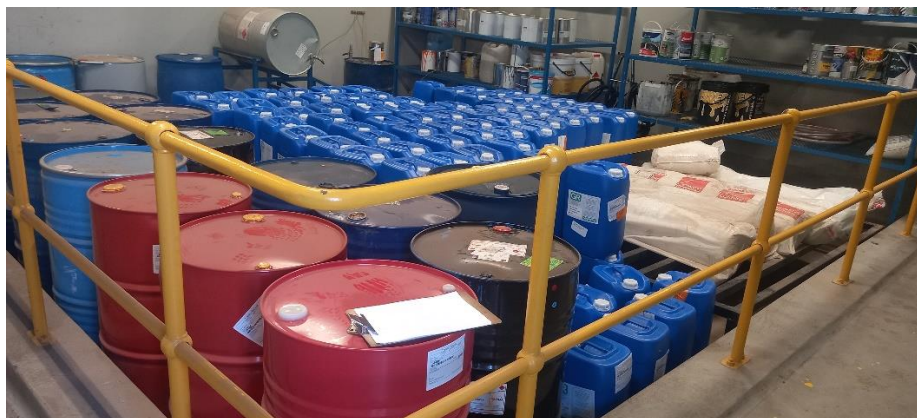
Feltex Building: Secluded Flammables Storage

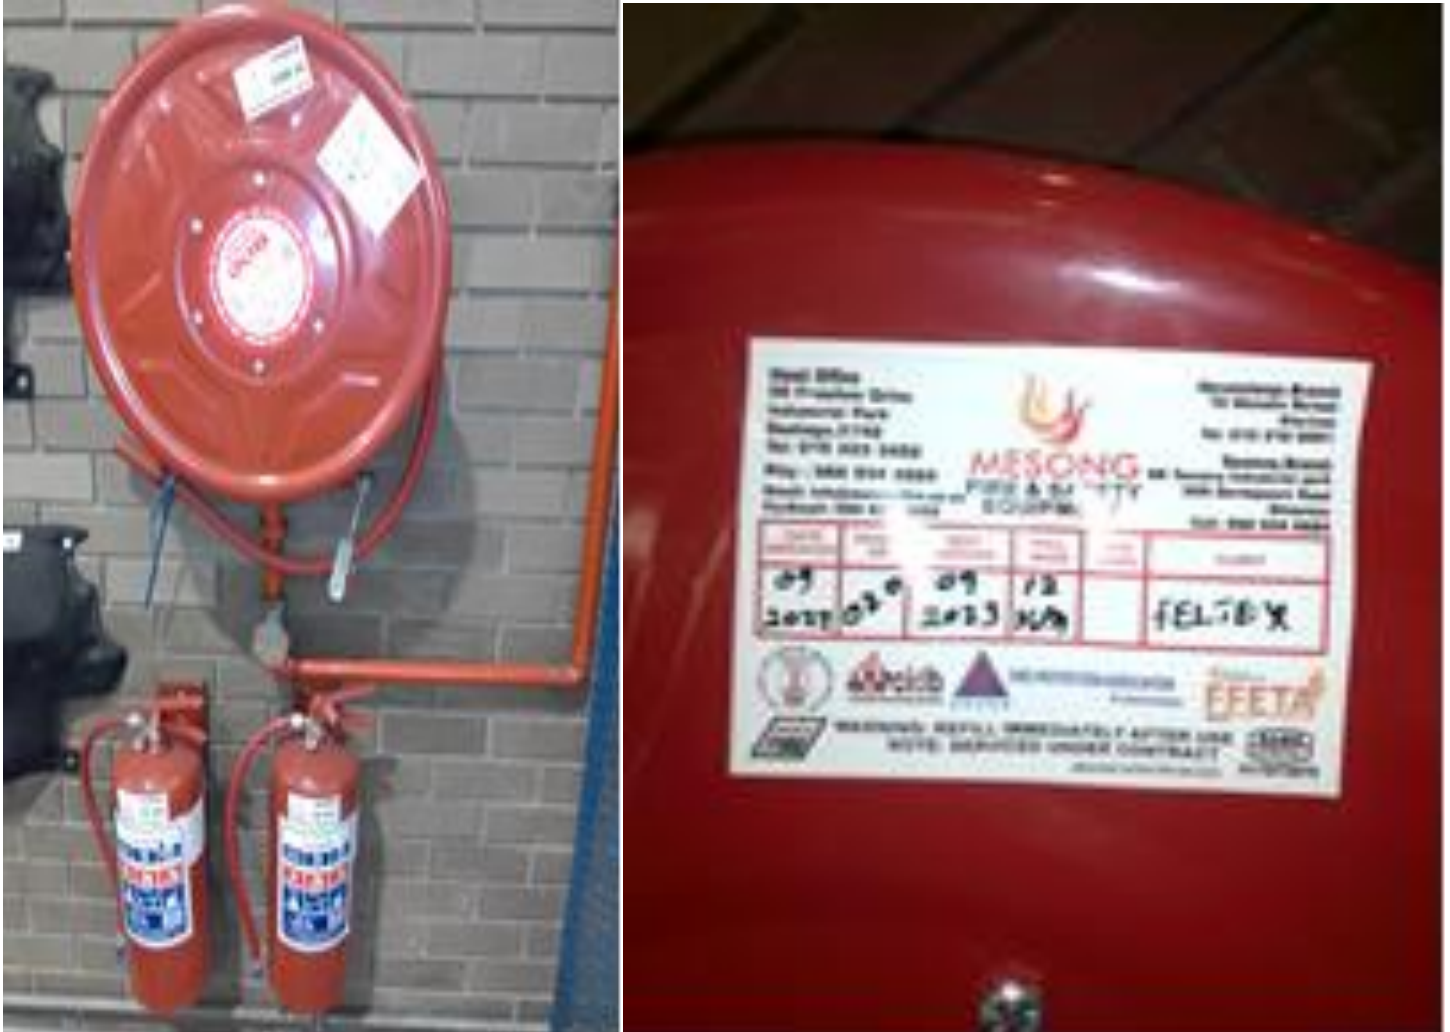
**Feltex Building:**

Note: Fire Extinguishers mounted just above floor level, instead of 1 metre above floor level

Fire Protection (Conveyor Maintenance)	<ul style="list-style-type: none"> o Sodecia 	Conveyor belt not greased.	Ensure that conveyor belt is cleaned and greased/ lubricated occasionally to mitigate the risk of friction on the moving parts which might give rise to a fire.	High
Fire Protection (Fire Extinguisher Mounting)	<ul style="list-style-type: none"> o Site wide 	Fire Extinguishers mounted just above floor level.	<ul style="list-style-type: none"> o Ensure that Fire Extinguishers are mounted 1 metre above floor level o Fire Extinguishers to be numbered 	High

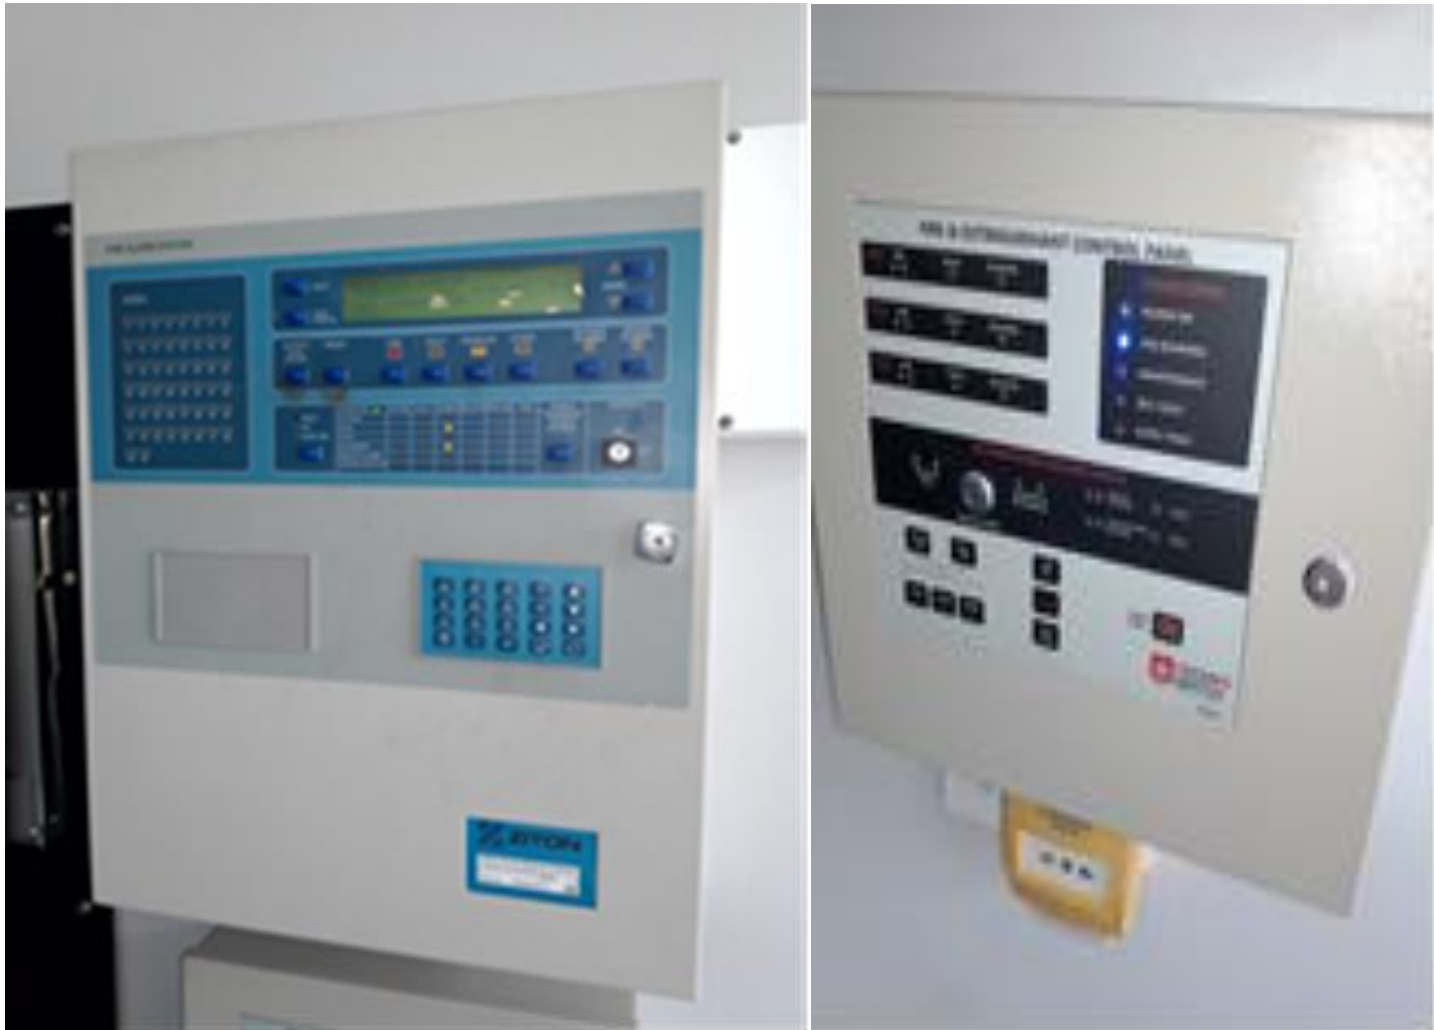
Feltex Building: Fire Panels (both detection and suppression systems) -All Zones Functioning Properly.

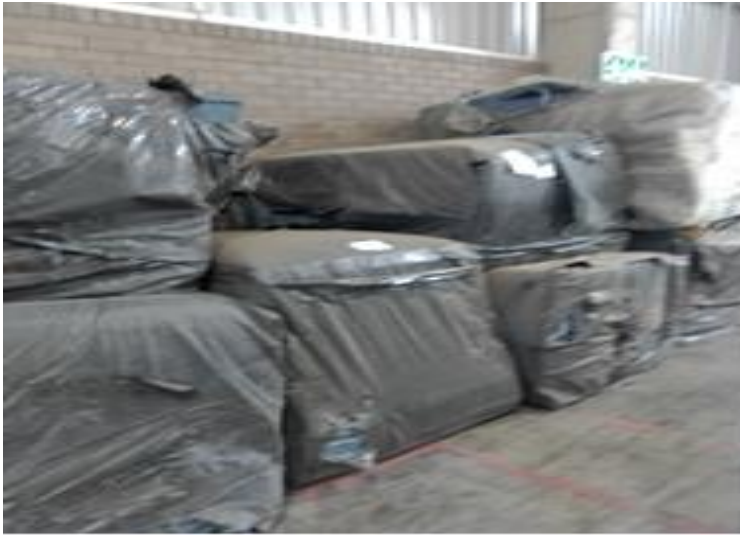
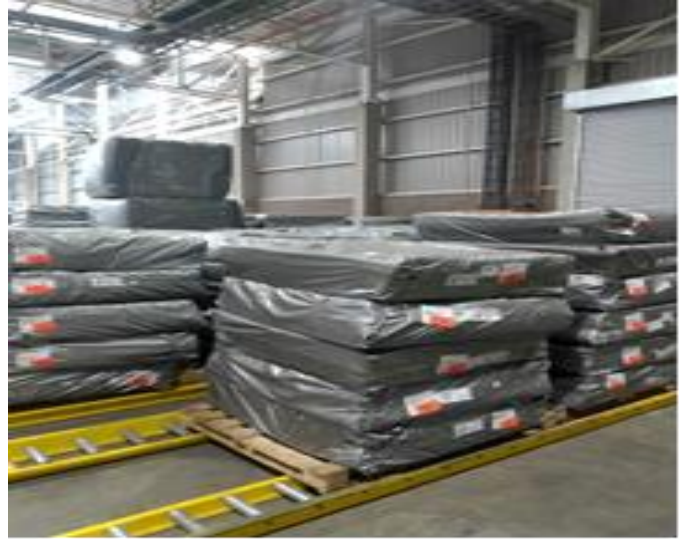
- Fire equipment not serviced in five out of eleven buildings
- Poor housekeeping particularly in the following buildings;
 - Feltex Building (Raw materials not properly stocked. Cardboard boxes stocked against the wall) **Fire Equipment serviced.**

Feltex Building: Raw Materials not properly stocked

ITEM	LOCATION	OBSERVATION	RECOMMENDATION	PRIORITY
Fire Protection (Service of Fire Equipment)	<ul style="list-style-type: none"> • Aerokladuys • Ford Frame • Supavut • ALSO • Valoworx 	Fire equipment was not serviced in five out of eleven buildings.	<ul style="list-style-type: none"> o Ensure that all Fire Equipment is serviced on time. o Client to furnish Automatic Sprinkler Inspection Bureau (ASIB) Certificates o Client to furnish Electrical Certificates of Compliance (CoCs) 	High
Fire Protection (Bad Housekeeping)	<ul style="list-style-type: none"> • Feltex • Aerokladuys • DSV • ALSO • Sodecia • Ford Frame • Hestro Harness 	<ul style="list-style-type: none"> o Raw materials not properly stocked, cardboard boxes stocked against the wall o Dumping site too close to the building o Unwanted waste material lying on the floor o Empty boxes outside, and obstructed Fire Points o Pallets blocking Emergency Exit o Boxes outside workshop, close to the gate o Boxes on the floor in the Server Room 	<ul style="list-style-type: none"> o Improve on housekeeping, implement and monitor waste management. o Ensure that all Fire Points and Emergency Exits are not obstructed. 	High

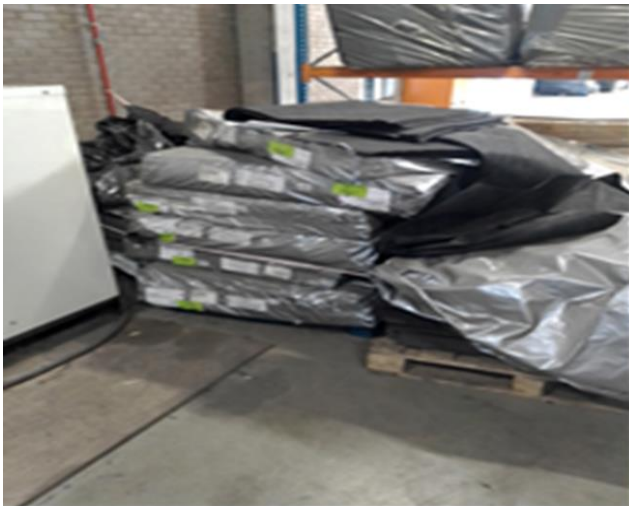
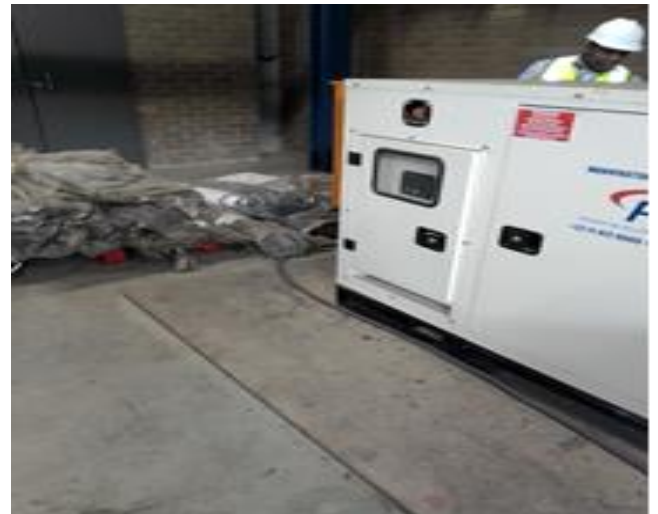
Feltex Building: Raw Materials Stored Next to A mini Substation

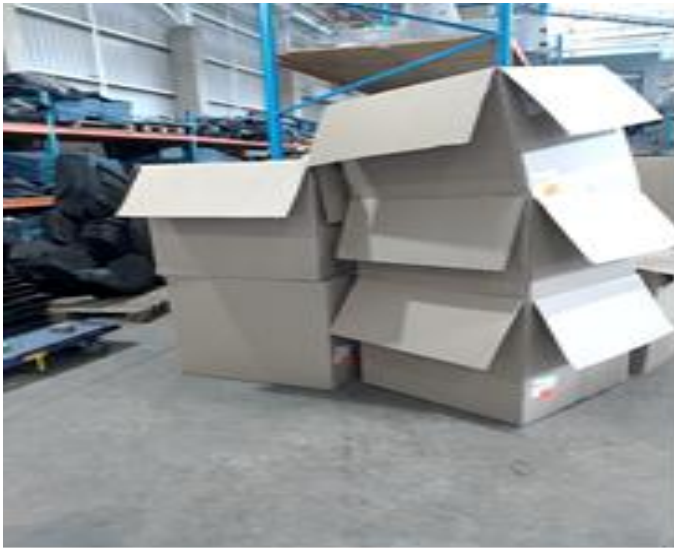
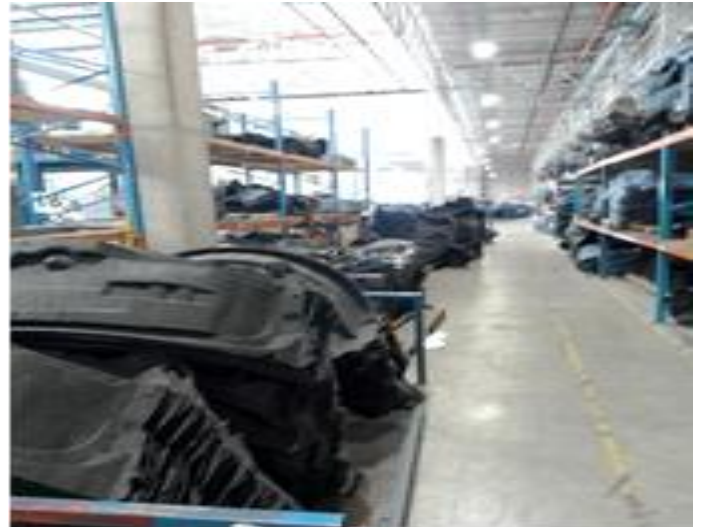
Feltex Building: Bad Housekeeping; Empty Boxes Adding To The Fire Load

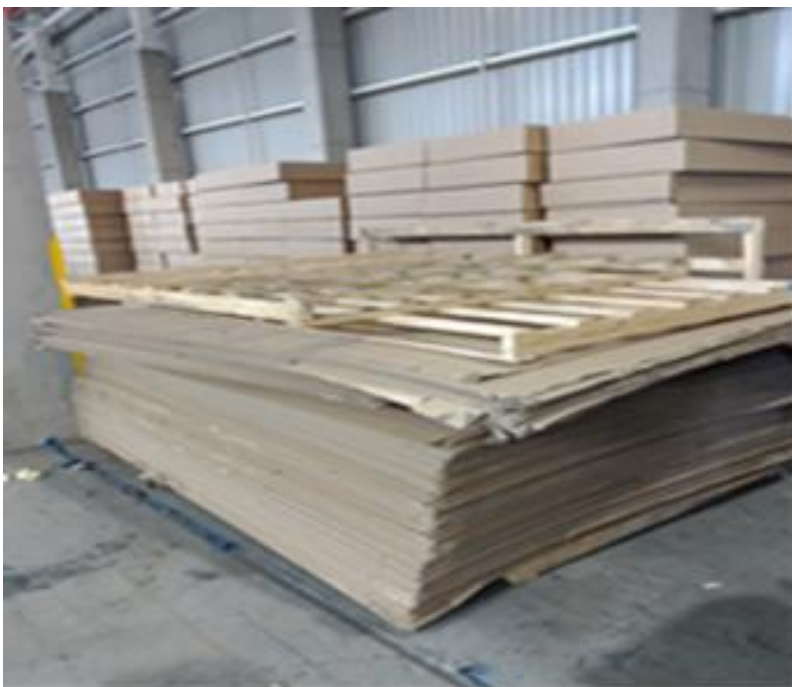
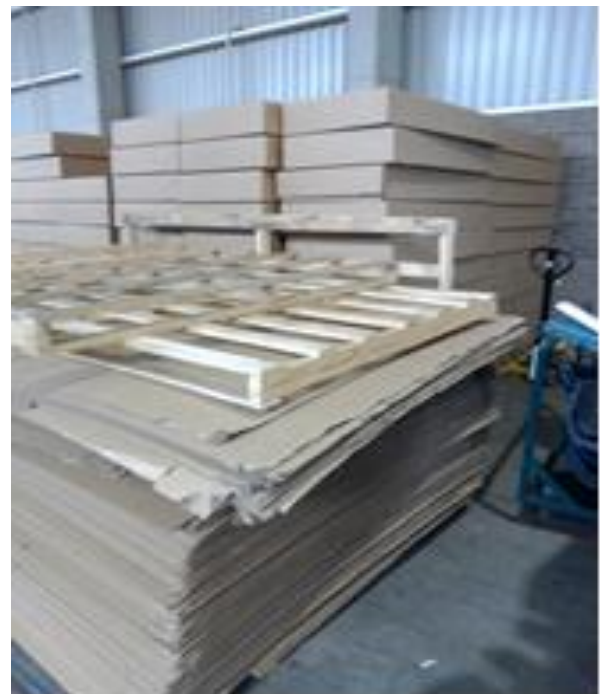
Feltex Building: Cardboard Boxes Stacked Against The Wall

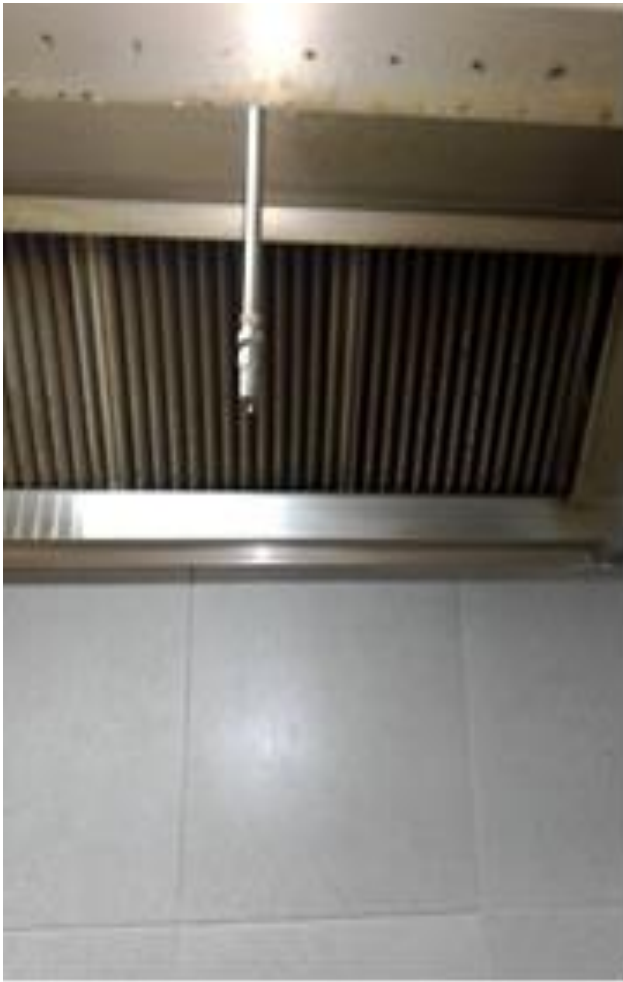
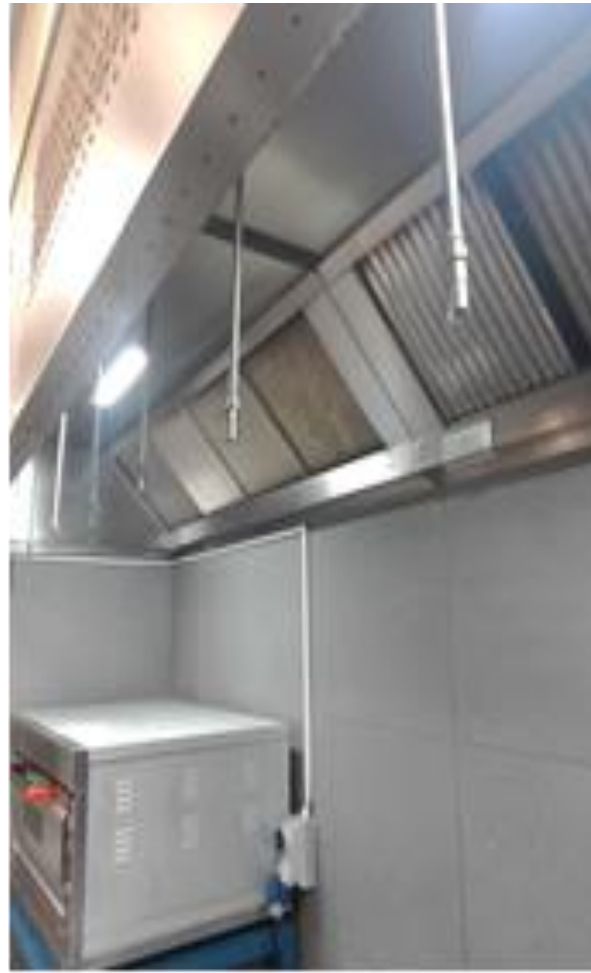
Fire Protection (Kitchen Extraction System)	<ul style="list-style-type: none"> ○ Feltex ○ Automold ○ Aeroklasduys 	The extraction system in the kitchen has not been cleaned for the past six months. Accumulation of fat and dust is a fire hazard.	<ul style="list-style-type: none"> ○ Ensure that all kitchen extraction systems are cleaned every three months. 	High

Feltex Building: Kitchen Extraction System

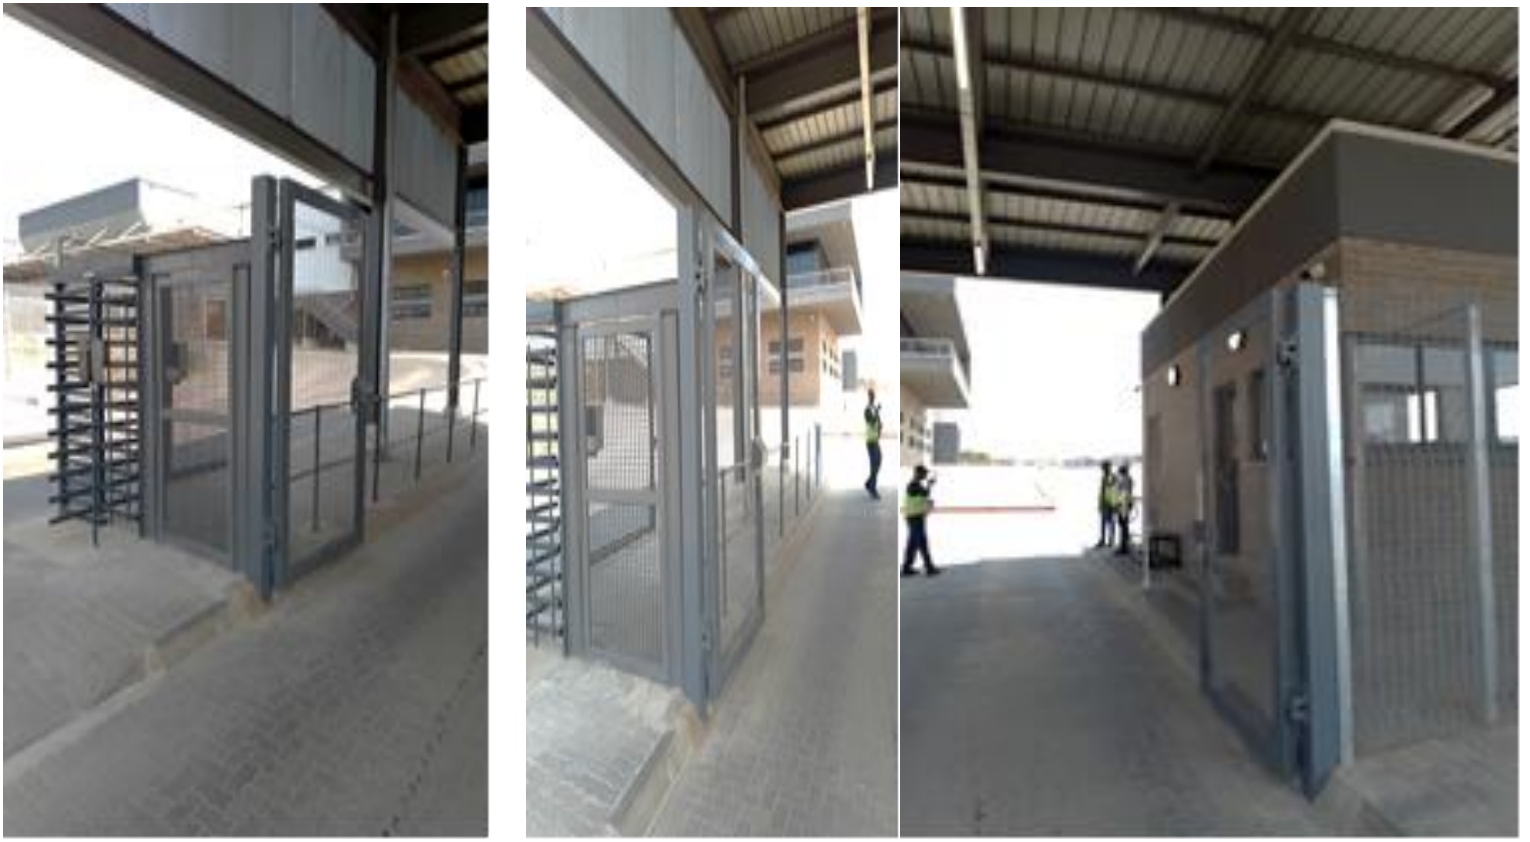
Feltex Building: The entrance to this building is guarded by two security guards during the day and at night, pedestrians use a bio-metric system to gain entry or exit from the building.

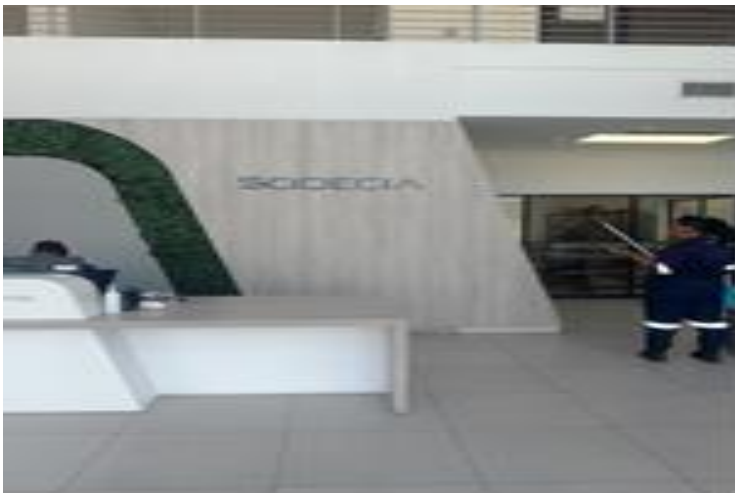
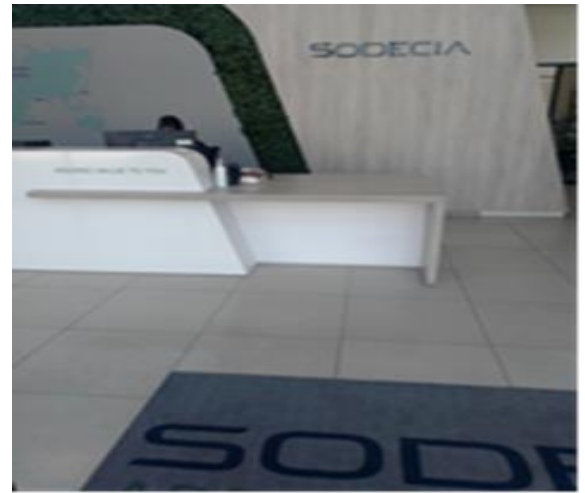
Sodecia Building: Access control systems are functioning properly.

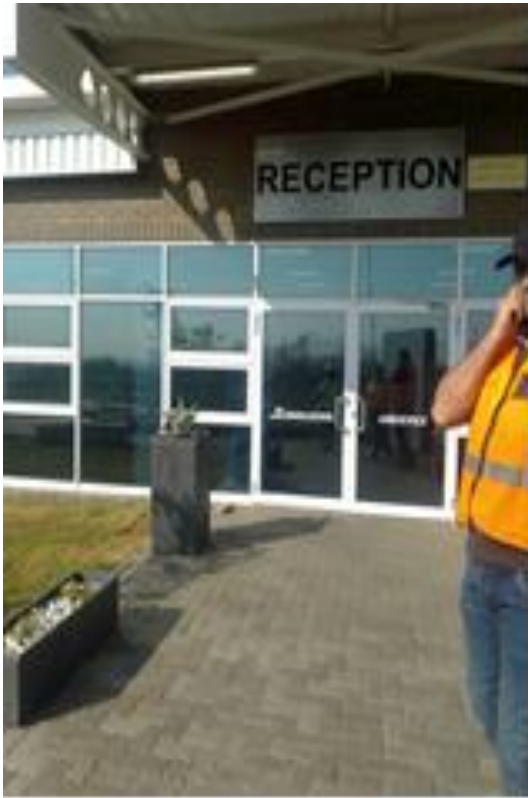
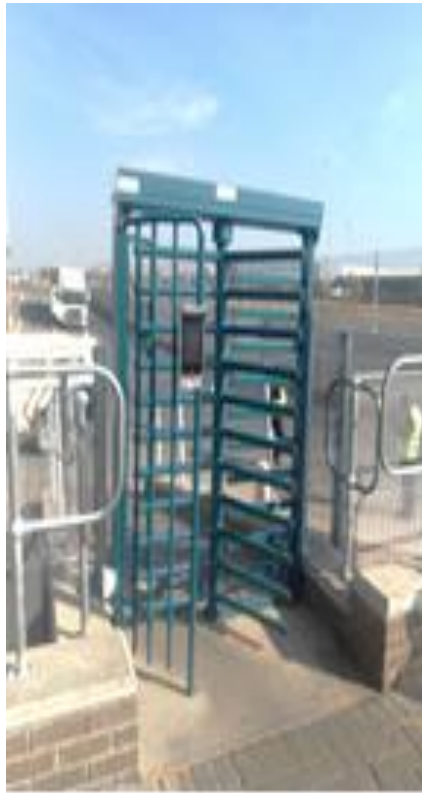
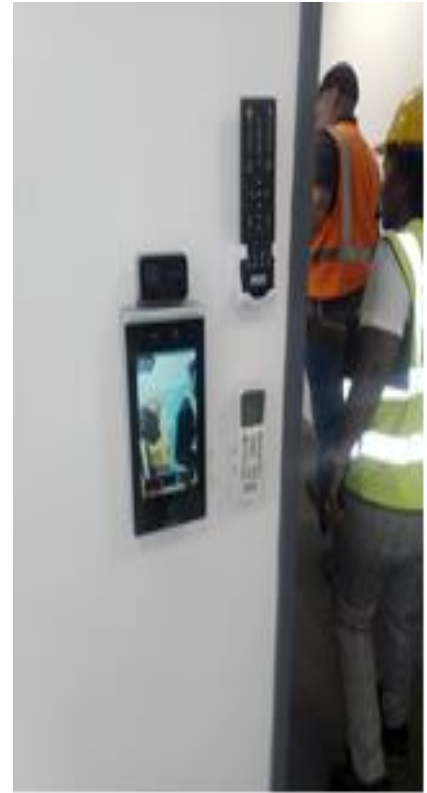
Faurecia Building: Access to the premises is controlled by guards, biometric system and a register

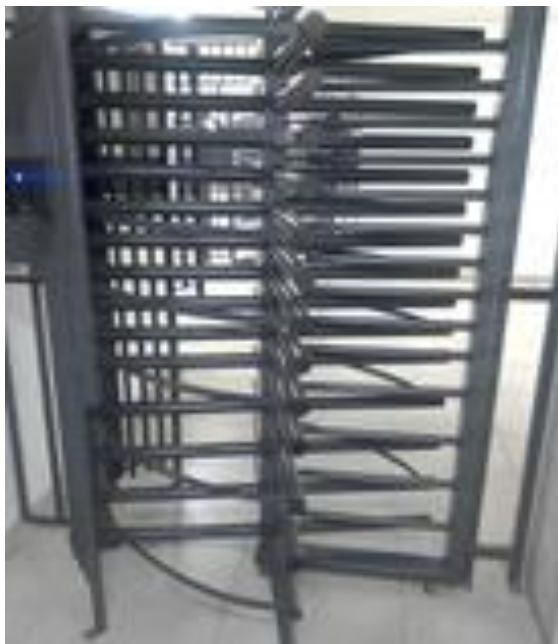
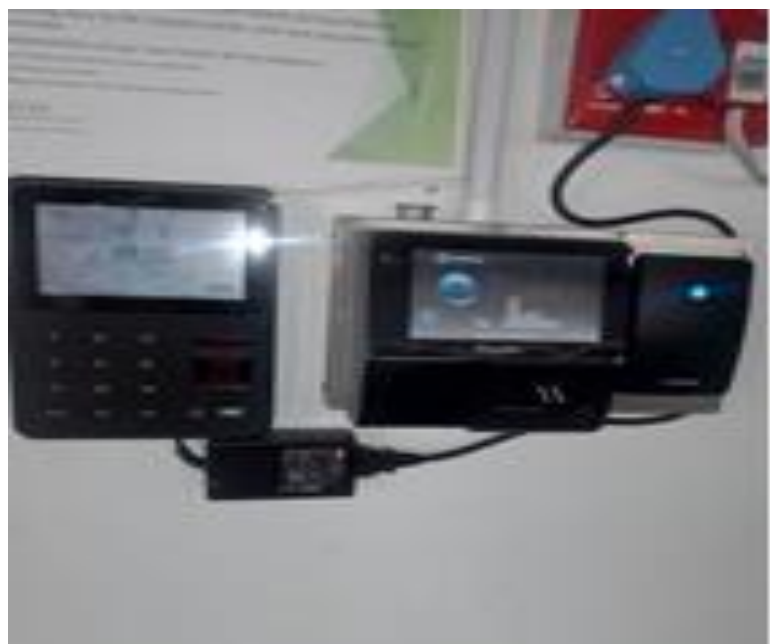
Ford Frame Building: Access control systems are functioning properly. Entry register system is also used for visitors.
