**SAICE 2010 Site Investigation Code of Practice Guided  
Tender Design or Basic Engineering Geotechnical Site  
Investigation Report for R/3, The Willows 340-JR, Region 6,  
Ward 86, Tshwane Metropolitan Municipality, Gauteng  
Province, South Africa**

**ROCKSOIL CONSULT PTY LTD**  
REG NO 2013/139402/07  
DIRECTOR: DIRK HERMAN WESSELS  
✉ **INFO@ROCKSOILCONSULT.CO.ZA**  
**SAGNASP: 400076/08**

**Client: Bvi Consulting Engineers (Pty) Ltd. Gauteng**

**Project number: RS18056**

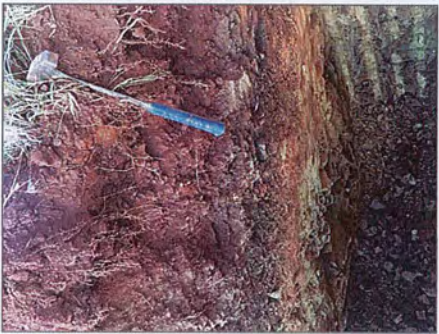
| <p>Test Pit no: TP01</p> <p>Note: Soil profile down to 2.80mbgl.</p> | <p>Test Pit no: TP01</p> <p>Note: Completely weathered shale.</p> |

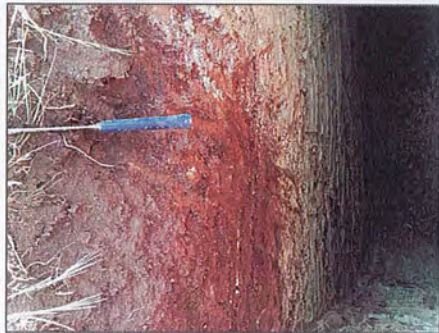
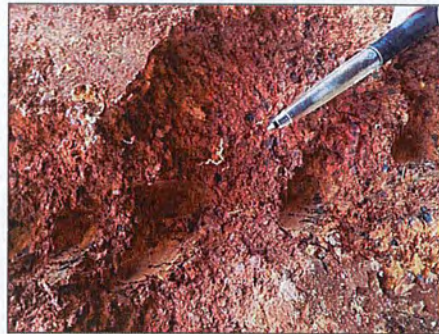
| <p>Test Pit no: TP02</p> <p>Note: Soil profile down to 3.30mbgl.</p> | <p>Test Pit no: TP02</p> <p>Note: Upper colluvium.</p> |

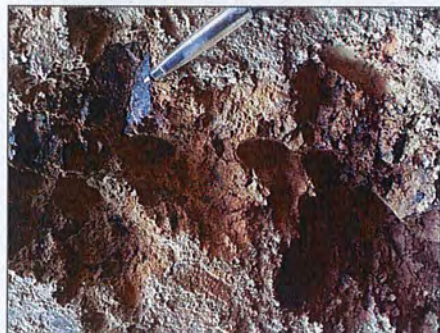
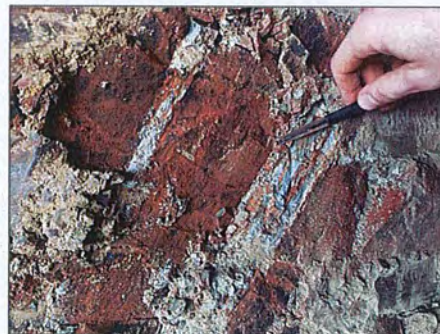
| <p>Test Pit no: TP02</p> <p>Note: Lower residual shale.</p> | <p>Test Pit no: TP02</p> <p>Note: Clay bands in highly weathered shale.</p> |

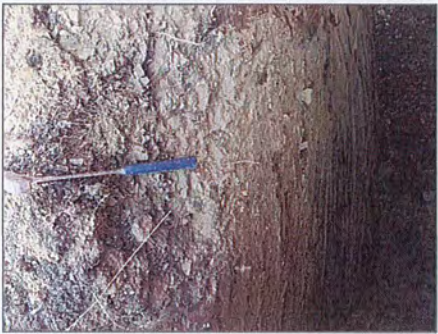
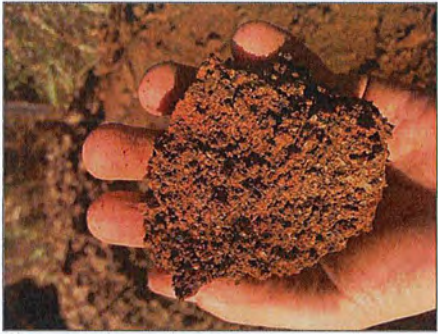
| <p>Test Pit no: TP03</p> <p>Note: Soil profile down to 3.30mbgl.</p> | <p>Test Pit no: TP03</p> <p>Note: Tested upper colluvium.</p> |

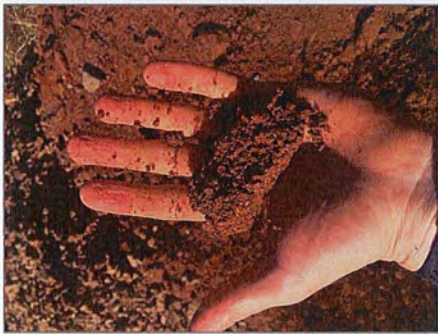
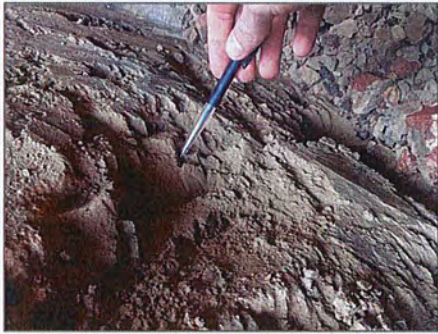
| <p>Test Pit no: TP03</p> <p>Note: Tested upper colluvium exhibiting plasticity.</p> | <p>Test Pit no: TP03</p> <p>Note: Lower completely weathered shale</p> |

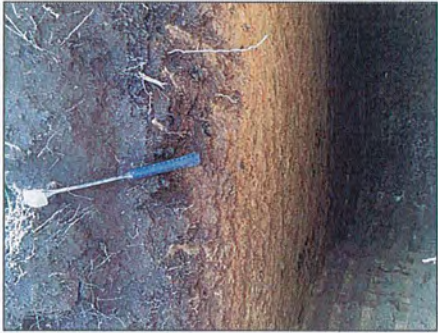
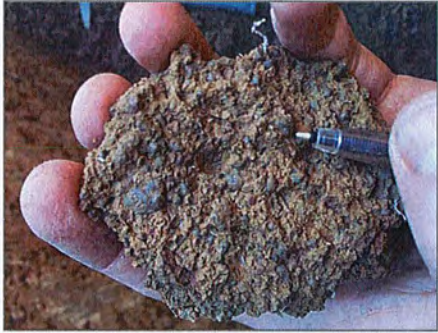
| <p>Test Pit no: TP04</p> <p>Note: Soil profile down to 2.90mbgl.</p> | <p>Test Pit no: TP04</p> <p>Note: Upper colluvium.</p> |

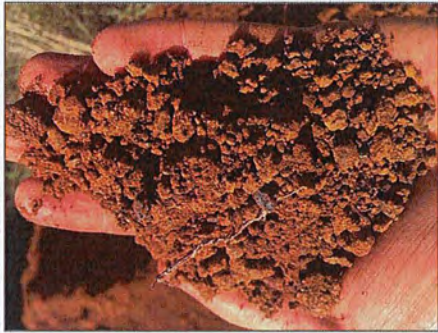
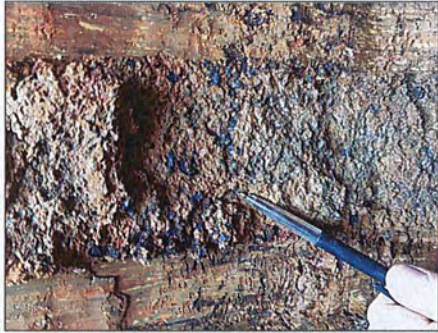
| <p>Test Pit no: TP04</p> <p>Note: Excavated tested upper colluvium</p> | <p>Test Pit no: TP04</p> <p>Note: Lower slightly ferruginised residual shale.</p> |

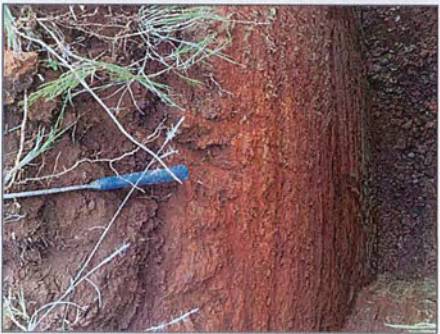
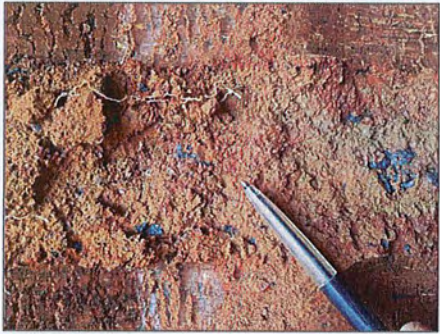
| <p>Test Pit no: TP05</p> <p>Note: Soil profile down to 3.20mbgl.</p> | <p>Test Pit no: TP05</p> <p>Note: Upper colluvium.</p> |

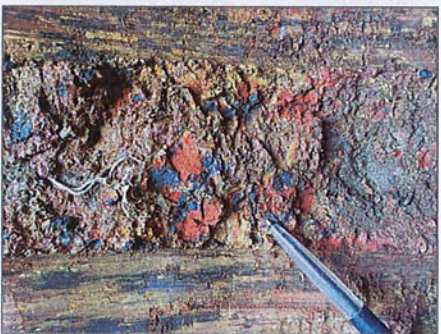
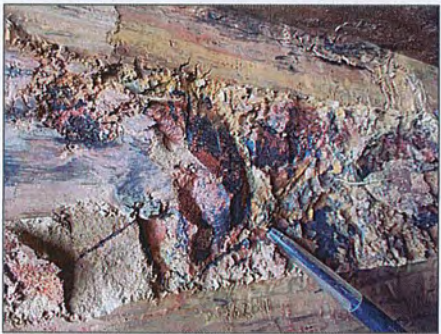
| <p>Test Pit no: TP05</p> <p>Note: Lower residual shale.</p> | <p>Test Pit no: TP05</p> <p>Note: Lower completely weathered shale</p> |

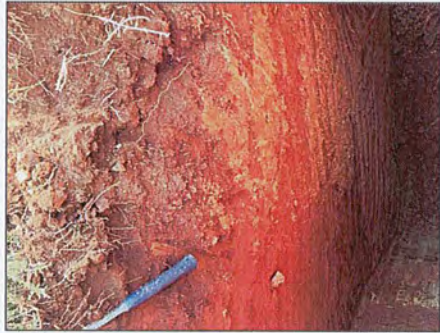
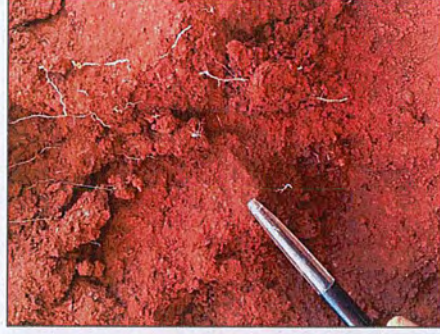
| <p>Test Pit no: TP06</p> <p>Note: Soil profile down to 3.20mbgl.</p> | <p>Test Pit no: TP06</p> <p>Note: Upper colluvium</p> |

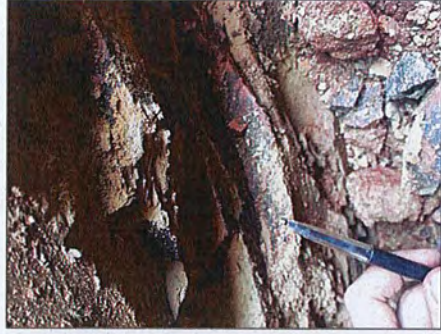
| <p>Test Pit no: TP06</p> <p>Note: Excavated tested colluvium.</p> | <p>Test Pit no: TP06</p> <p>Note: Lower completely weathered shale.</p> |

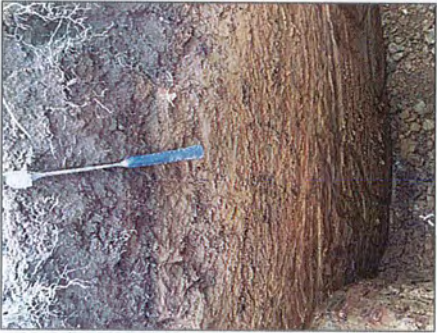
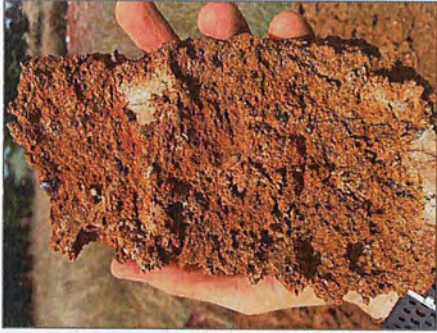
| <p>Test Pit no: TP07</p> <p>Note: Soil profile down to 3.10mbgl.</p> | <p>Test Pit no: TP07</p> <p>Note: Upper ferruginised colluvium.</p> |

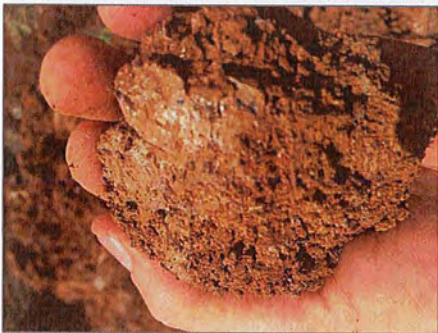
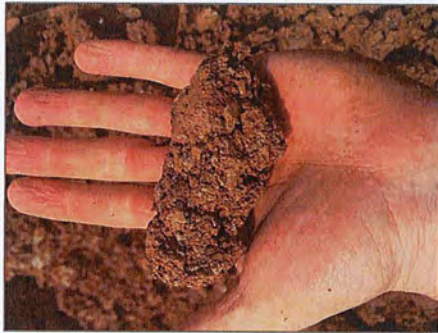
| <p>Test Pit no: TP07</p> <p>Note: Fissured structure indicates potential heave in lower residual shale.</p> | <p>Test Pit no: TP07</p> <p>Note: Plasticity exhibited by lower residual shale.</p> |

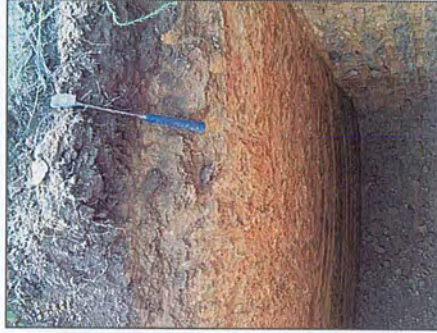
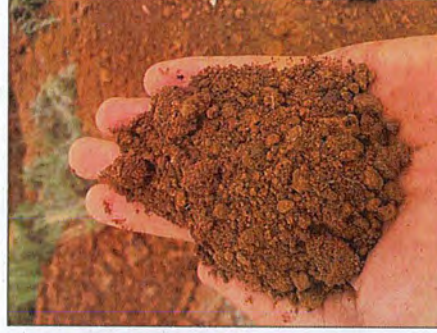
| <p>Test Pit no: TP08</p> <p>Note: Soil profile down to 2.80mbgl.</p> | <p>Test Pit no: TP08</p> <p>Note: Upper colluvium.</p> |

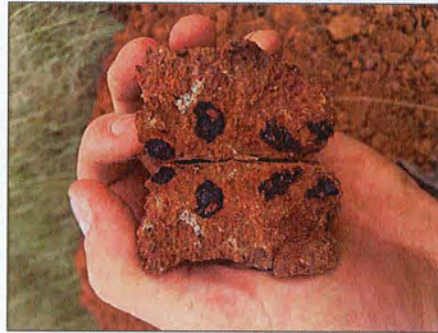
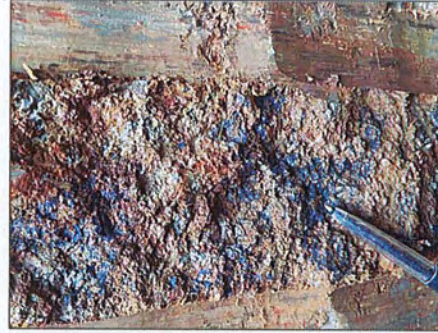
| <p>Test Pit no: TP08</p> <p>Note: Excavated lower reworked residual shale.</p> | <p>Test Pit no: TP08</p> <p>Note: Lower reworked residual shale.</p> |

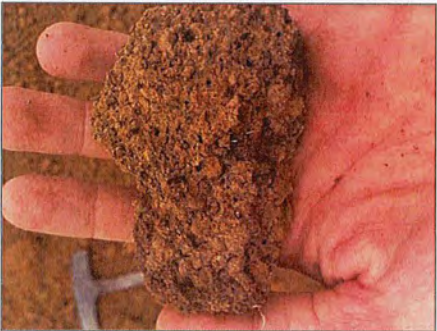
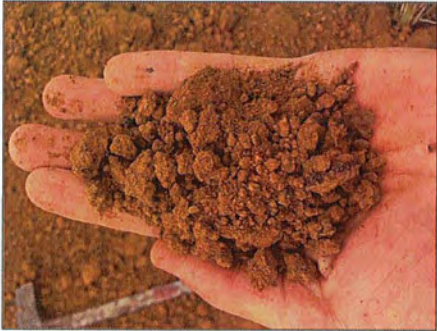
| <p>Test Pit no: TP09</p> <p>Note: Upper colluvium exhibiting open structure.</p> | <p>Test Pit no: TP09</p> <p>Note: Excavated and tested upper colluvium.</p> |

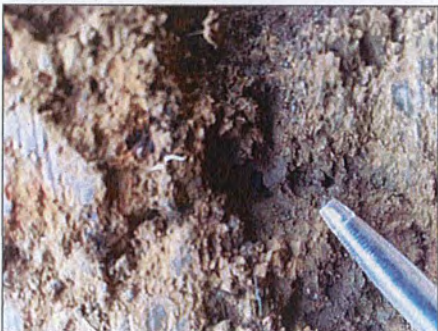
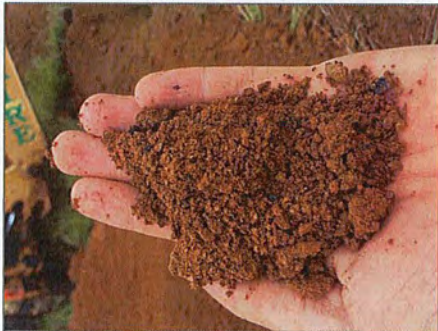
| <p>Test Pit no: TP09</p> <p>Note: Lower reworked residual shale exhibiting open structure.</p> | <p>Test Pit no: TP09</p> <p>Note: Excavated lower reworked residual shale.</p> |

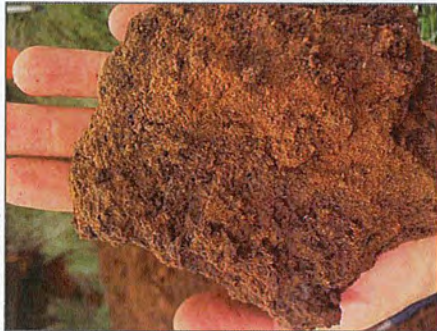
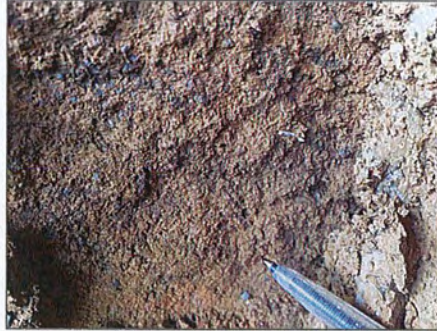
| <p>Test Pit no: TP10</p> <p>Note: Upper uncontrolled fill exhibiting open structure.</p> | <p>Test Pit no: TP10</p> <p>Note: Colluvium exhibiting open structure.</p> |

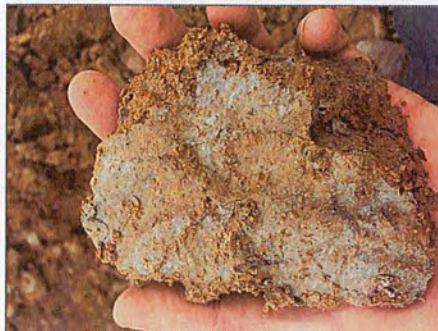
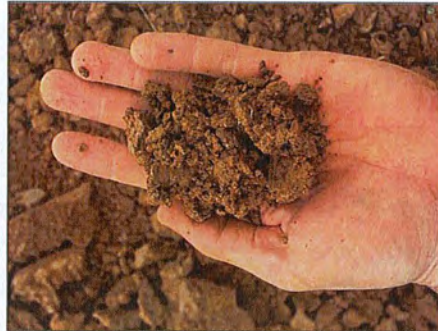
| <p>Test Pit no: TP10</p> <p>Note: Fissured surfaces present in lower residual shale.</p> | <p>Test Pit no: TP10</p> <p>Note: Excavated and tested lower residual shale.</p> |

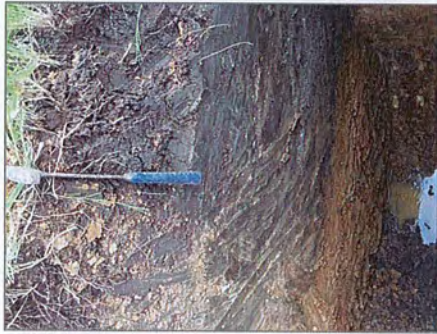
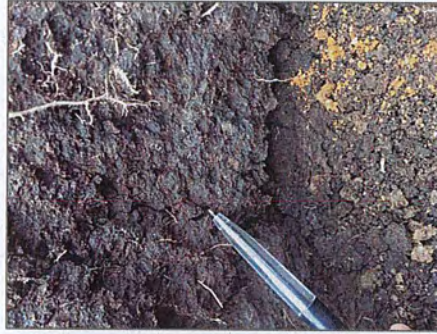
| <p>Test Pit no: TP11</p> <p>Note: Soil profile down to 2.90mbgl.</p> | <p>Test Pit no: TP11</p> <p>Note: Upper alluvium.</p> |

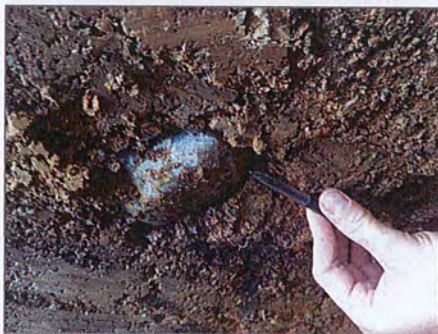
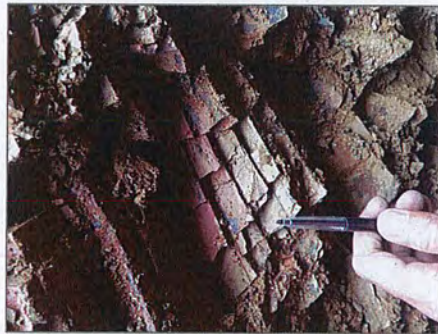
| <p>Test Pit no: TP11</p> <p>Note: Lower alluvium.</p> | <p>Test Pit no: TP11</p> <p>Note: Lower highly weathered shale.</p> |

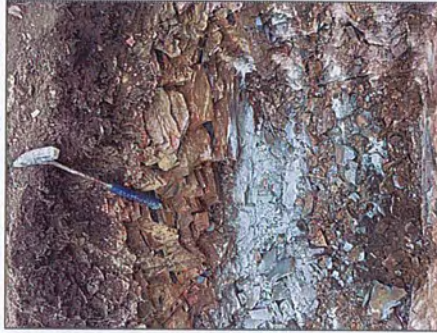
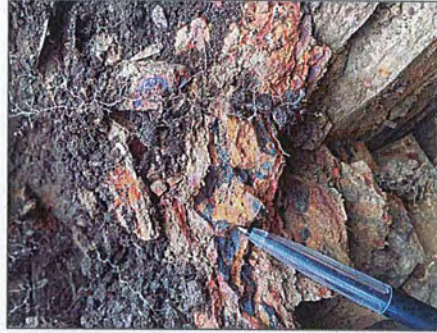
| <p>Test Pit no: TP12</p> <p>Note: Soil profile down to 0.95mbgl.</p> | <p>Test Pit no: TP12</p> <p>Note: Upper reworked completely weathered shale.</p> |

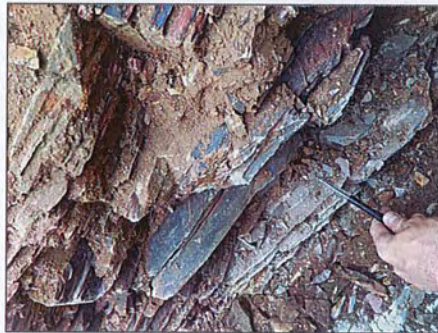
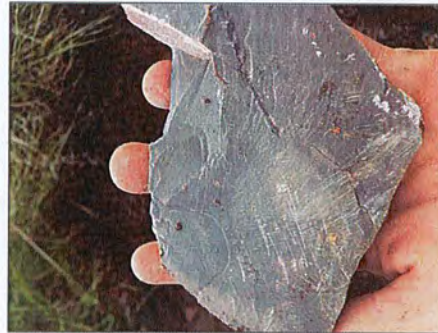
| <p>Test Pit no: TP12</p> <p>Note: Lower moderately weathered shale.</p> | <p>Test Pit no: TP12</p> <p>Note: Excavated and test shale rock.</p> |

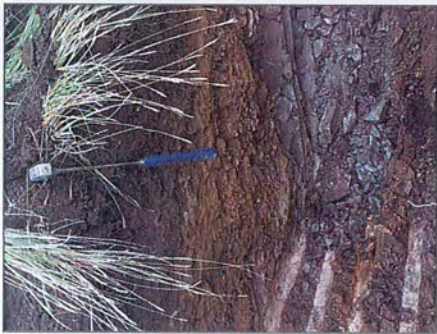
Test Pit no: TP13

Note: Soil profile down to 1.30mbgl.

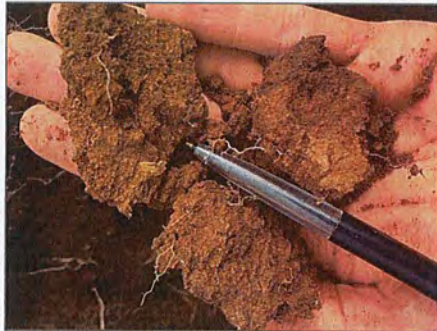
Test Pit no: TP13

Note: Upper colluvium.

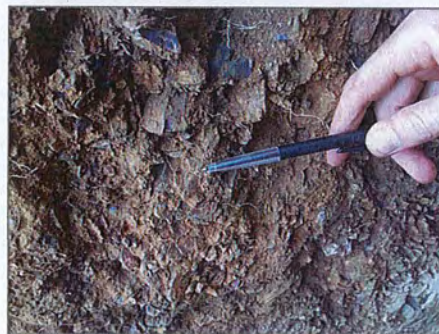
Test Pit no: TP13

Note: Lower reworked completely weathered shale.

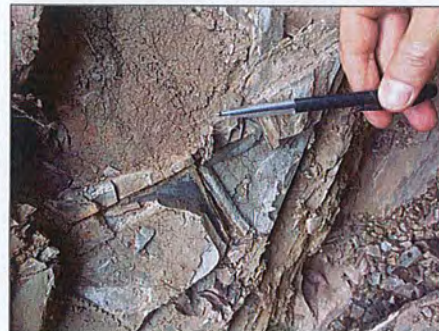
Test Pit no: TP13

Note: Lower moderately weathered shale.

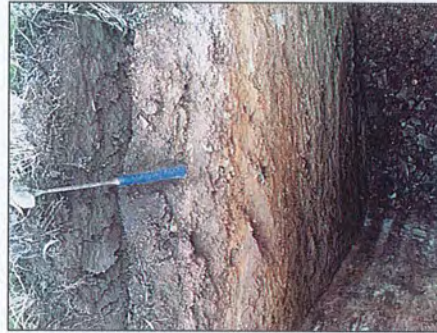
Test Pit no: TP14

Note: Soil profile down to 2.80mbgl.

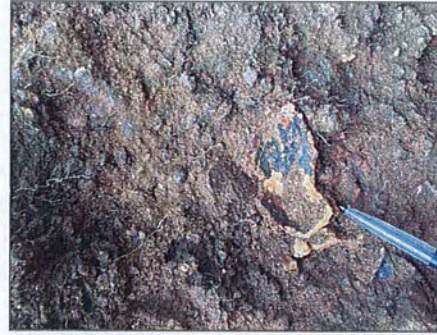
Test Pit no: TP14

Note: Upper colluvium.

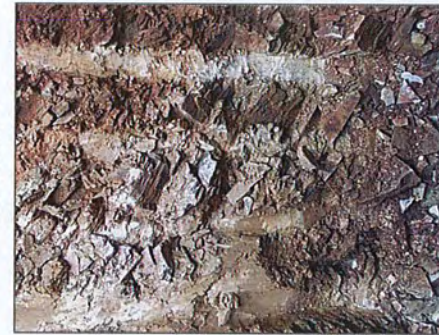
Test Pit no: TP14

Note: Shales dipping in a northerly direction.

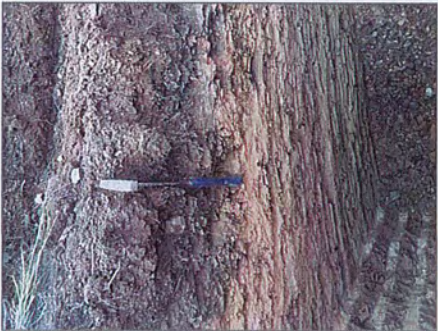
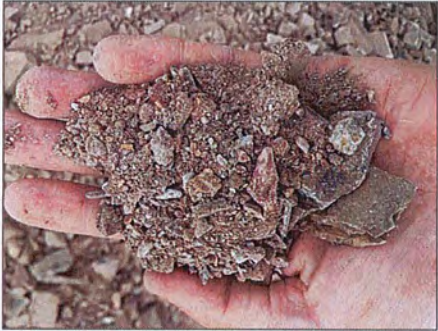
| <p>Test Pit no: TP15</p> <p>Note: Soil profile down to 2.30mbgl.</p> | <p>Test Pit no: TP15</p> <p>Note: Excavated lower shale.</p> |

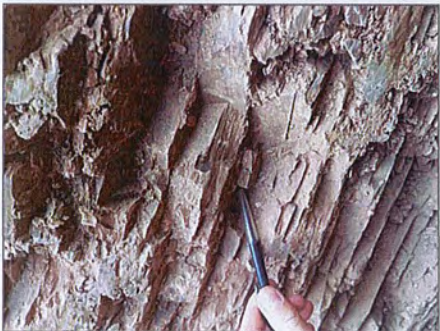
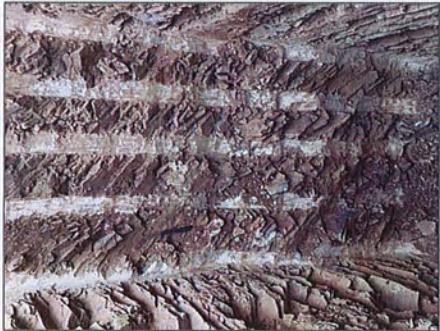
| <p>Test Pit no: TP15</p> <p>Note: Lower highly weathered shale.</p> | <p>Test Pit no: TP15</p> <p>Note: Shales dipping in a northerly direction.</p> |

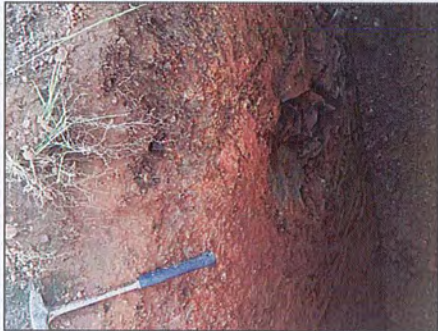
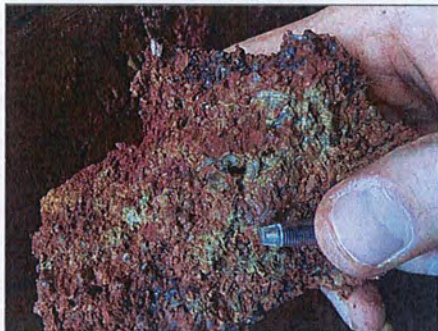
| <p>Test Pit no: TP16</p> <p>Note: Soil profile down to 3.10mbgl.</p> | <p>Test Pit no: TP16</p> <p>Note: Lower reworked residual shale exhibiting open structure.</p> |

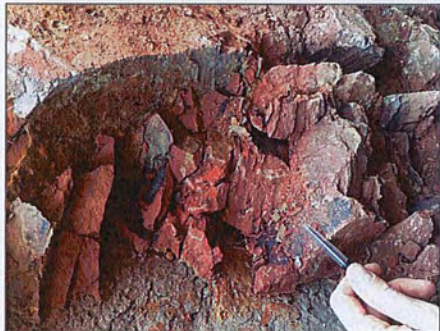
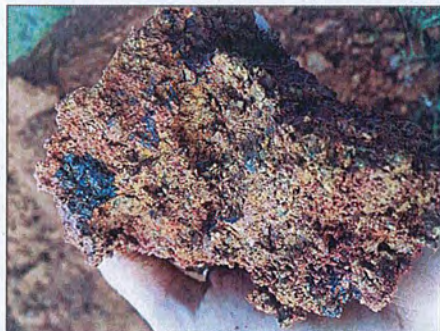
| <p>Test Pit no: TP16</p> <p>Note: Pinnacle in trial pit face</p> | <p>Test Pit no: TP16</p> <p>Note: Lower reworked residual shale.</p> |

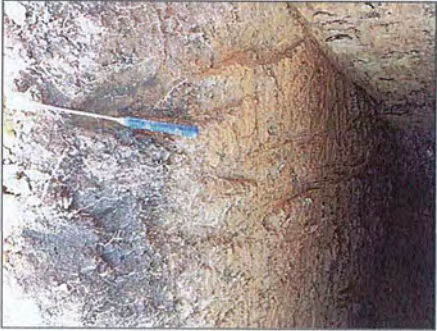
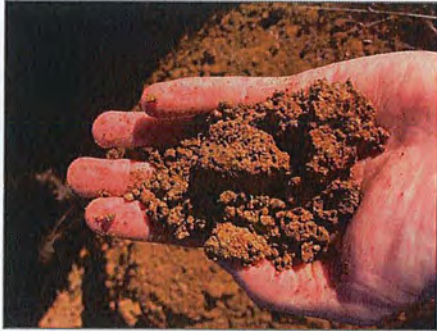
| <p>Test Pit no: TP17</p> <p>Note: Soil profile down to 3.30mbgl.</p> | <p>Test Pit no: TP17</p> <p>Note: Upper slightly ferruginised colluvium.</p> |

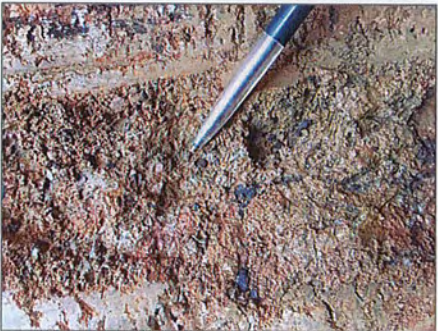
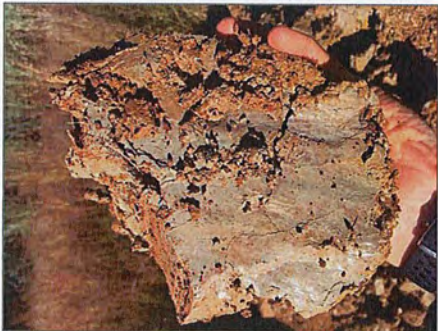
| <p>Test Pit no: TP17</p> <p>Note: Upper slightly ferruginised colluvium.</p> | <p>Test Pit no: TP17</p> <p>Note: Fissured surfaces exhibited by lower residual shale.</p> |

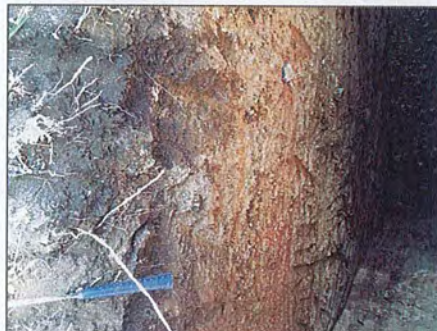
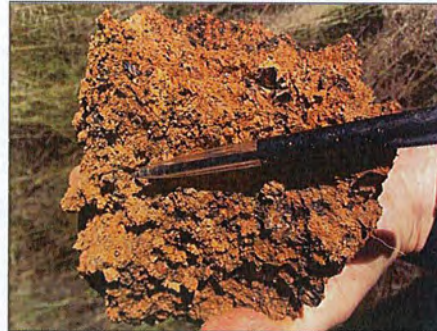
| <p>Test Pit no: TP18</p> <p>Note: Soil profile down to 3.30mbgl.</p> | <p>Test Pit no: TP18</p> <p>Note: Upper colluvium.</p> |

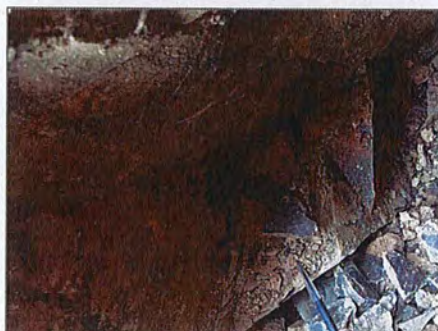
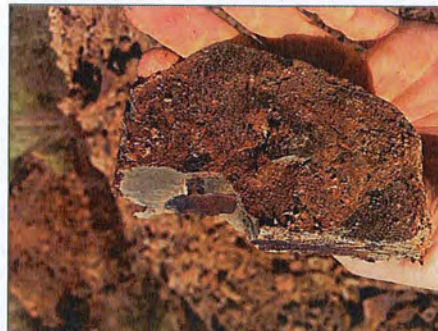
| <p>Test Pit no: TP18</p> <p>Note: Lower completely weathered shale.</p> | <p>Test Pit no: TP18</p> <p>Note: Excavated shale material.</p> |

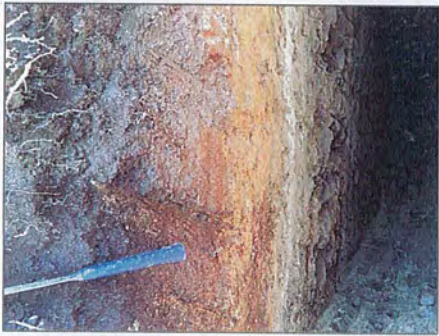
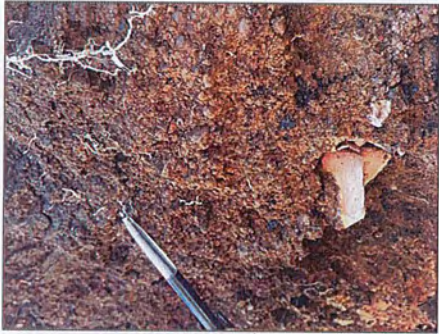
| <p>Test Pit no: TP19</p> <p>Note: Soil profile down to 3.30mbgl.</p> | <p>Test Pit no: TP19</p> <p>Note: Upper colluvium.</p> |

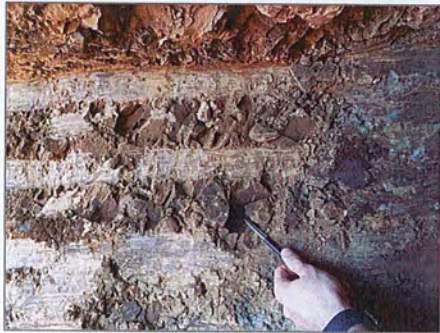
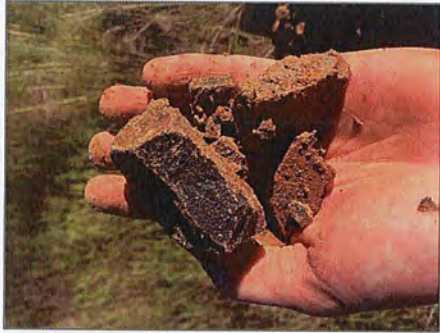
| <p>Test Pit no: TP19</p> <p>Note: Lower moderately to completely weathered shale.</p> | <p>Test Pit no: TP19</p> <p>Note: Excavated shale material.</p> |

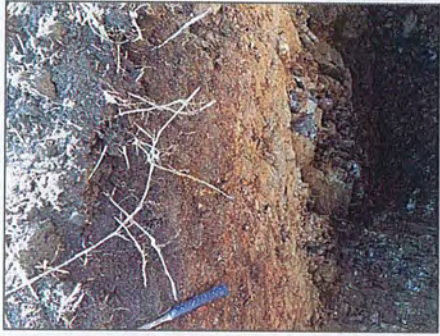
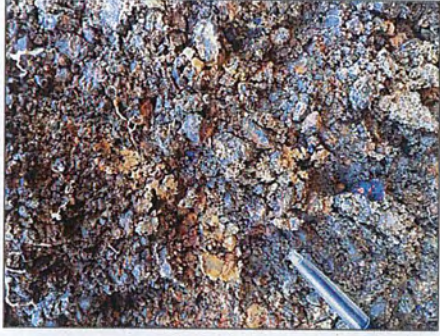
| <p>Test Pit no: TP20</p> <p>Note: Soil profile down to 3.00mbgl.</p> | <p>Test Pit no: TP20</p> <p>Note: Upper colluvium.</p> |

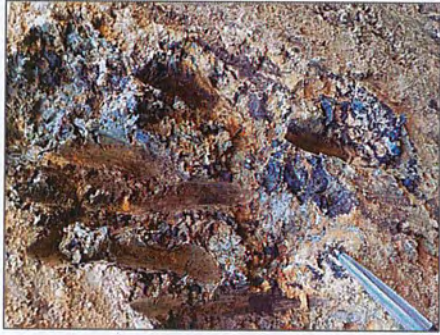
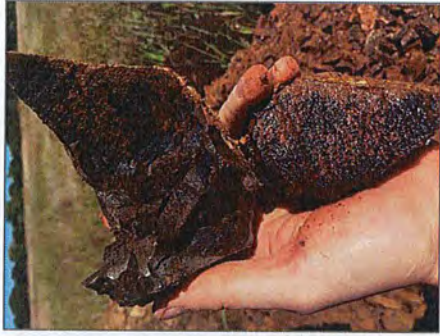
| <p>Test Pit no: TP20</p> <p>Note: Reworked completely weathered shale.</p> | <p>Test Pit no: TP20</p> <p>Note: Excavated lower shale material with wet joint faces.</p> |

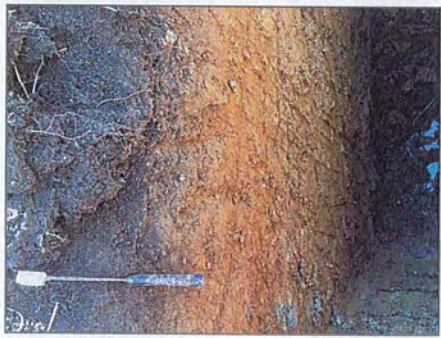
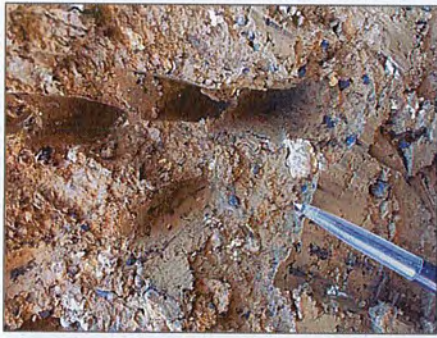
| <p>Test Pit no: TP21</p> <p>Note: Soil profile down to 3.00mbgl.</p> | <p>Test Pit no: TP21</p> <p>Note: Residual shale with ferricrete nodules and calcrete concretions.</p> |

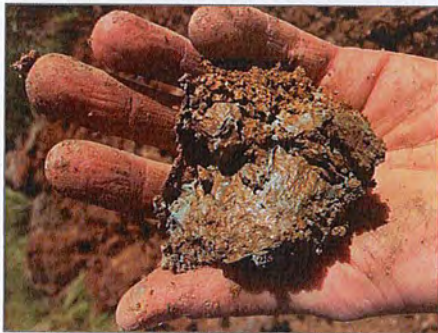
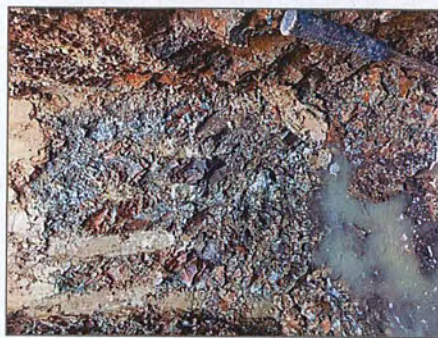
| <p>Test Pit no: TP21</p> <p>Note: Residual shale exhibiting fissured surfaces.</p> | <p>Test Pit no: TP21</p> <p>Note: Lower shale dipping in a northerly direction with water seepage present.</p> |

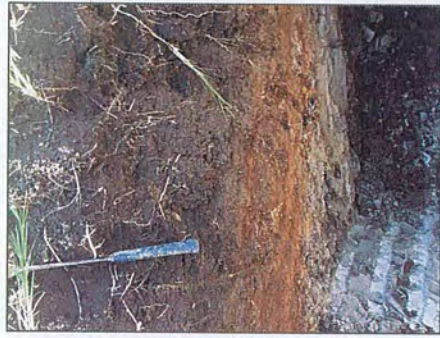
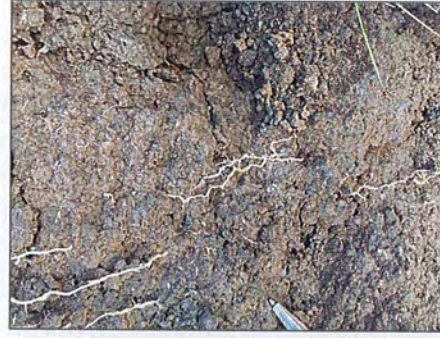
| <p>Test Pit no: TP22</p> <p>Note: Soil profile down to 1.80mbgl.</p> | <p>Test Pit no: TP22</p> <p>Note: Upper colluvium.</p> |

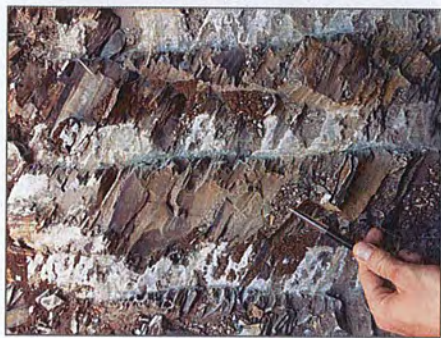
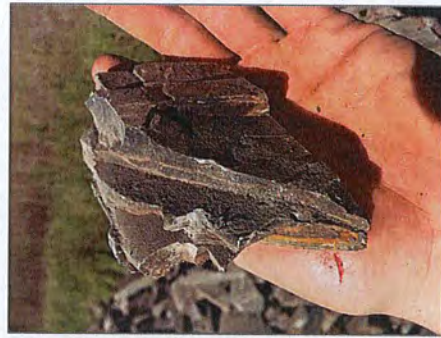
| <p>Test Pit no: TP22</p> <p>Note: Lower shale dipping in a northerly direction.</p> | <p>Test Pit no: TP22</p> <p>Note: Excavated lower shale material.</p> |

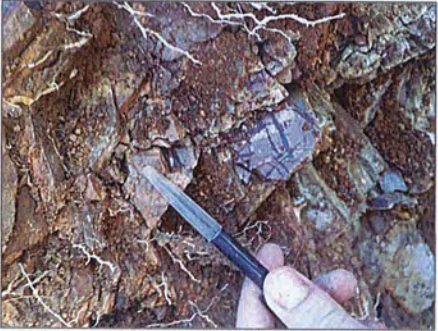
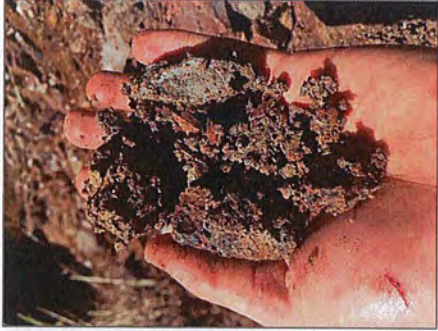
| <p>Test Pit no: TP23</p> <p>Note: Reworked residual shale.</p> | <p>Test Pit no: TP23</p> <p>Note: Excavated reworked residual shale.</p> |

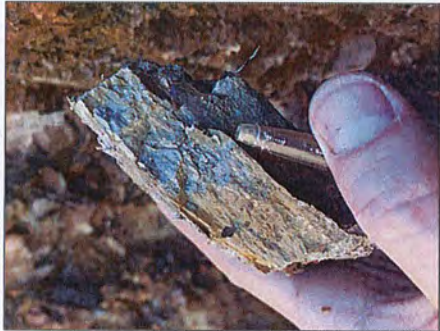
| <p>Test Pit no: TP23</p> <p>Note: Lower slightly weathered shale.</p> | <p>Test Pit no: TP23</p> <p>Note: Excavated slightly weathered shale.</p> |

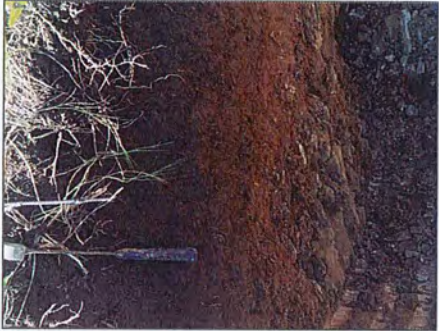
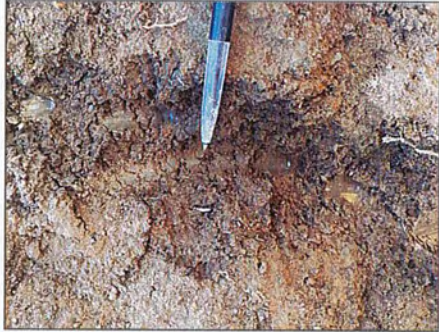
| <p>Test Pit no: TP24</p> <p>Note: Soil profile down to 1.80mbgl.</p> | <p>Test Pit no: TP24</p> <p>Note: Upper colluvium.</p> |

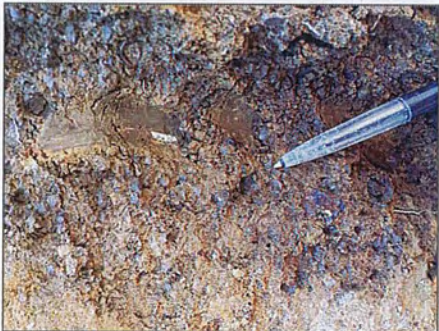
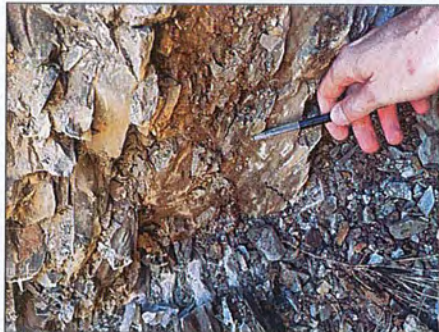
| <p>Test Pit no: TP24</p> <p>Note: Reworked residual shale.</p> | <p>Test Pit no: TP24</p> <p>Note: Lower moderately weathered shale.</p> |

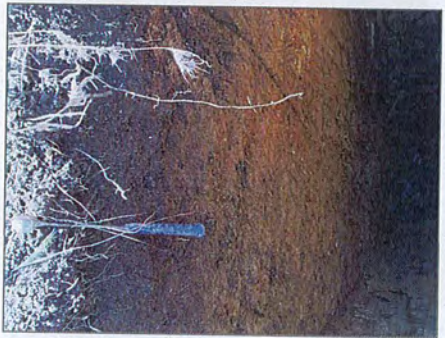
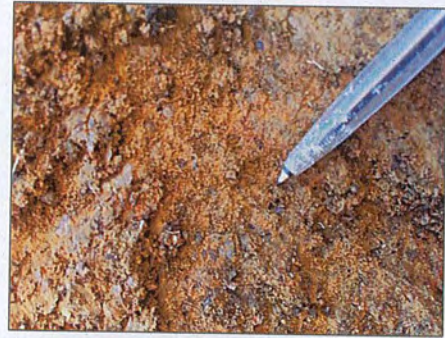
| <p>Test Pit no: TP25</p> <p>Note: Soil profile down to 3.40mbgl.</p> | <p>Test Pit no: TP25</p> <p>Note: Upper colluvium exhibiting open structure.</p> |

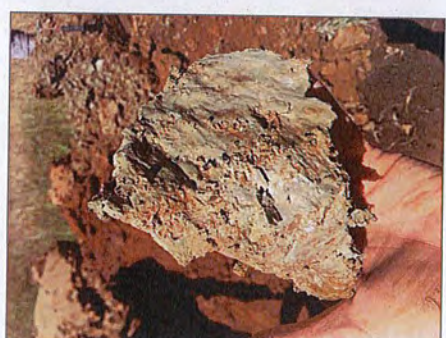
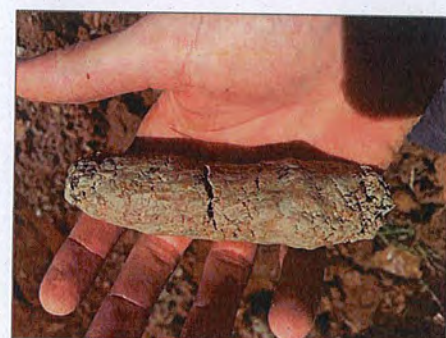
| <p>Test Pit no: TP25</p> <p>Note: Lower residual shale exhibiting fissured structure.</p> | <p>Test Pit no: TP25</p> <p>Note: Lower residual shale possesses plasticity.</p> |

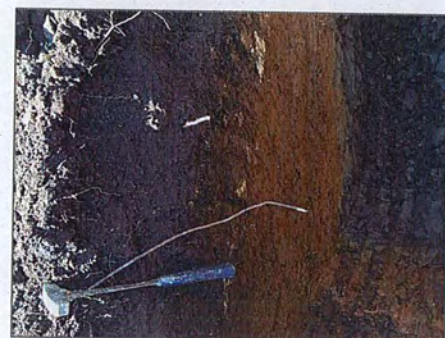
| <p>Test Pit no: TP26</p> <p>Note: Soil profile down to 2.40mbgl.</p> | <p>Test Pit no: TP26</p> <p>Note: Upper slightly ferruginised colluvium.</p> |

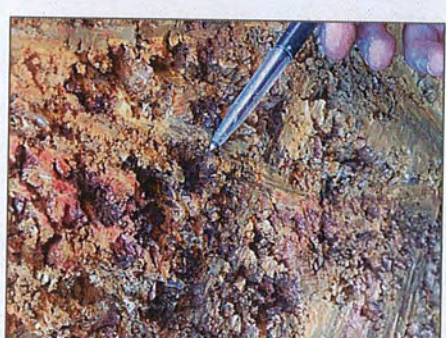
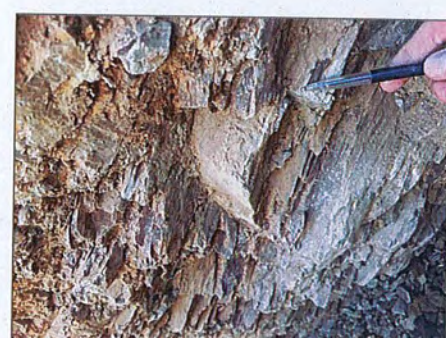
| <p>Test Pit no: TP26</p> <p>Note: Lower reworked residual shale.</p> | <p>Test Pit no: TP26</p> <p>Note: Lower moderately to highly weathered shale.</p> |

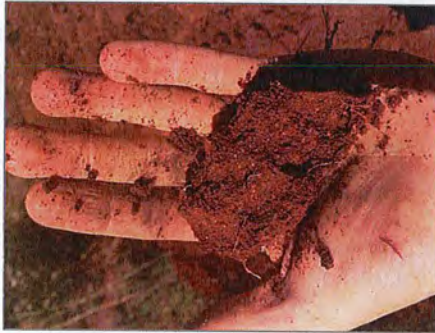
Test Pit no: TP27

Note: Excavated upper uncontrolled fill.

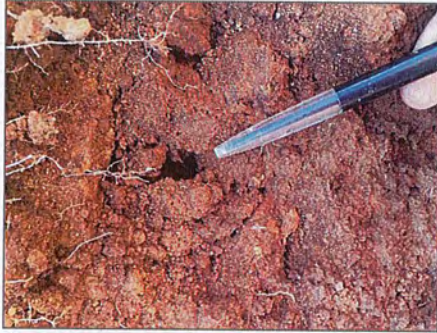
Test Pit no: TP27

Note: Upper uncontrolled fill exhibiting open structure.

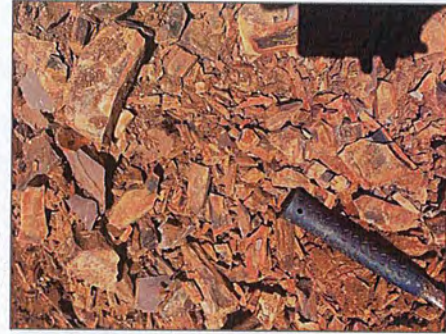
Test Pit no: TP27

Note: Excavated lower moderately to slightly weathered shale.

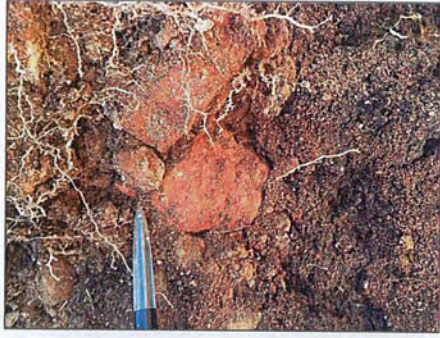
Test Pit no: TP28

Note: Upper uncontrolled fill.

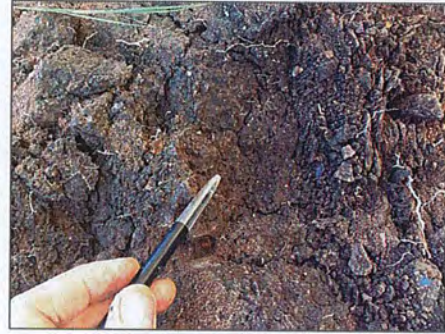
Test Pit no: TP28

Note: Upper disturbed ground.

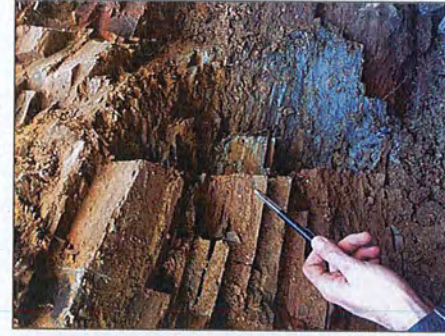
Test Pit no: TP28

Note: Lower slightly weathered shale.

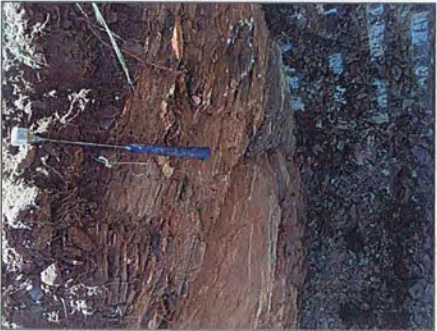
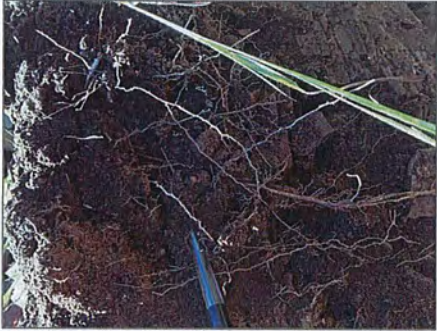
| <p>Test Pit no: TP29</p> | <p>Test Pit no: TP29</p> |

| <p>Note: Soil profile down to 1.50mbgl.</p> | <p>Note: Upper disturbed ground.</p> |

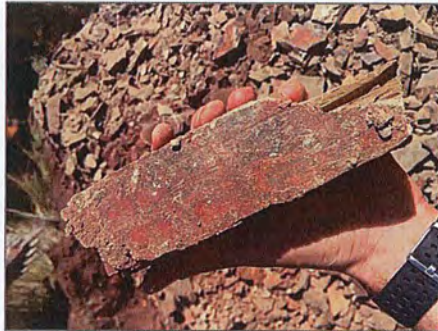
| <p>Test Pit no: TP29</p> | <p>Test Pit no: TP29</p> |

| <p>Note: Lower moderately to slightly weathered shale.</p> | <p>Note: Excavated lower slightly weathered shale.</p> |

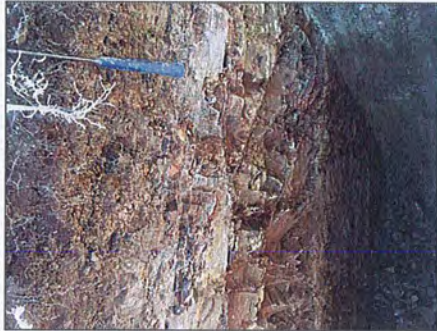
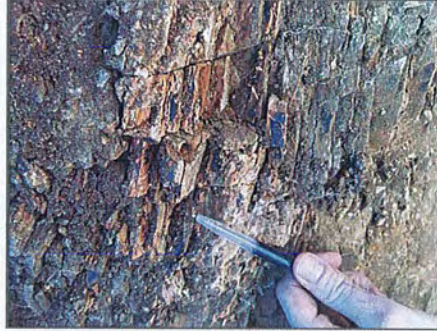
| <p>Test Pit no: TP30</p> | <p>Test Pit no: TP30</p> |

| <p>Note: Soil profile down to 3.00mbgl.</p> | <p>Note: Upper reworked completely weathered shale.</p> |

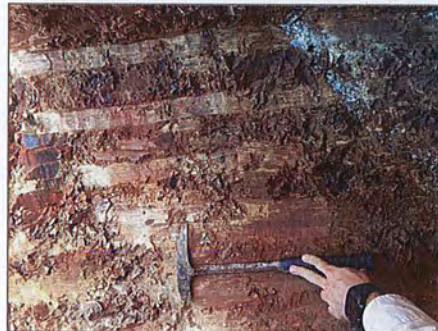
| <p>Test Pit no: TP30</p> | <p>Test Pit no: TP30</p> |

| <p>Note: Bands of clayey sand in lower slightly to highly weathered shale.</p> | <p>Note: Different degrees of weathering in shale layers.</p> |

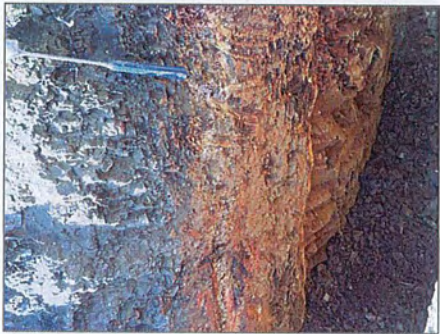
| <p>Test Pit no: TP31</p> <p>Note: Soil profiles down to 3.00mbgl.</p> | <p>Test Pit no: TP31</p> <p>Note: Different degrees of weathering in shale layers.</p> |

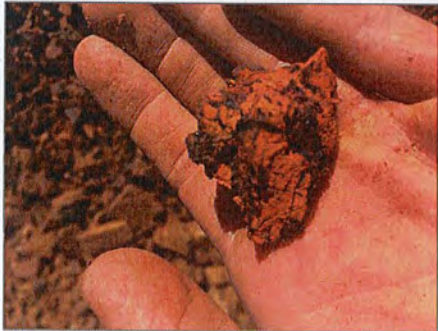
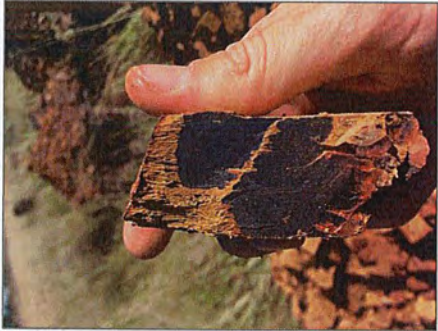
| <p>Test Pit no: TP31</p> <p>Note: Excavated completely weathered shale material.</p> | <p>Test Pit no: TP31</p> <p>Note: Excavated highly to completely weathered shale.</p> |

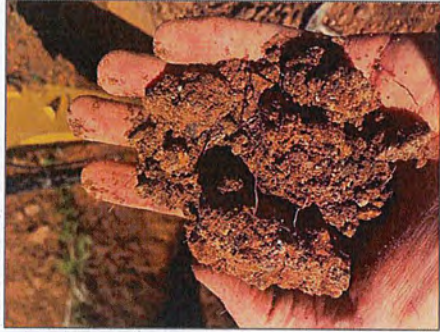
| <p>Test Pit no: TP32</p> <p>Note: Excavated and tested upper ferruginised material.</p> | <p>Test Pit no: TP32</p> <p>Note: Typical weakly to moderately weathered ferricrete concretions.</p> |

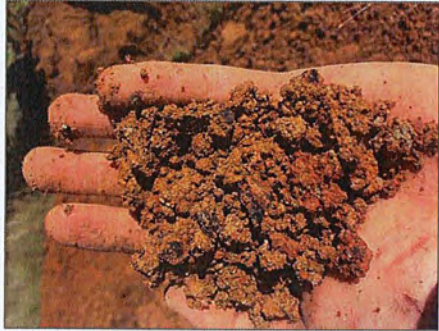
| <p>Test Pit no: TP32</p> <p>Note: Excavated and tested reworked residual shale.</p> | <p>Test Pit no: TP32</p> <p>Note: Plasticity exhibited by reworked residual shale.</p> |

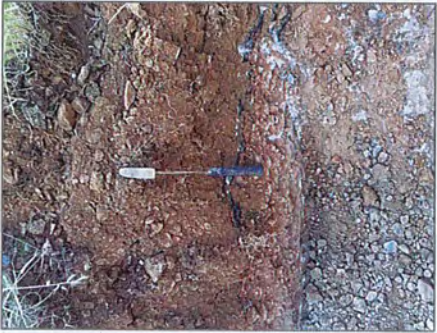
| <p>Test Pit no: TP33</p> <p>Note: Soil profile down to 0.60mbgl.</p> | <p>Test Pit no: TP33</p> <p>Note: Upper uncontrolled fill.</p> |

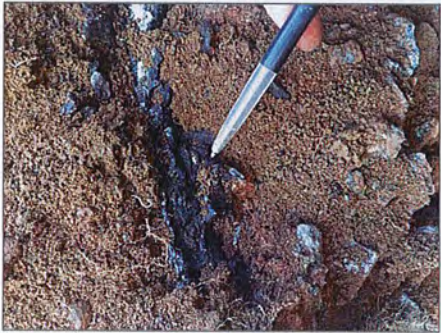
| <p>Test Pit no: TP33</p> <p>Note: Lower asphalt layer.</p> | <p>Test Pit no: TP33</p> <p>Note: Lower cemented coarse aggregate.</p> |

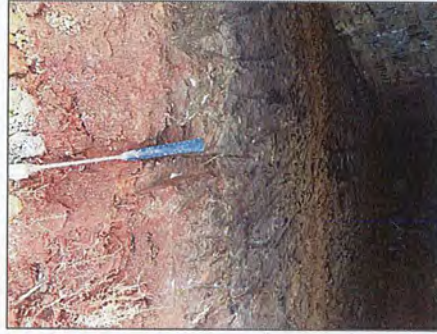
| <p>Test Pit no: TP34</p> <p>Note: Soil profile down to 3.20mbgl.</p> | <p>Test Pit no: TP34</p> <p>Note: Upper uncontrolled fill.</p> |

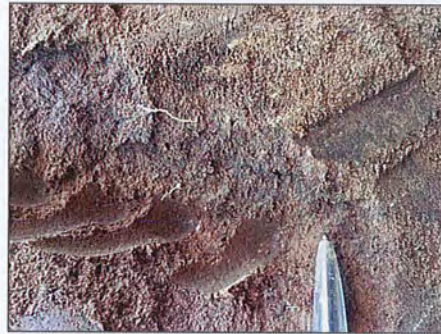
| <p>Test Pit no: TP34</p> <p>Note: Disturbed ground exhibiting open structure.</p> | <p>Test Pit no: TP34</p> <p>Note: Lower residual shale.</p> |

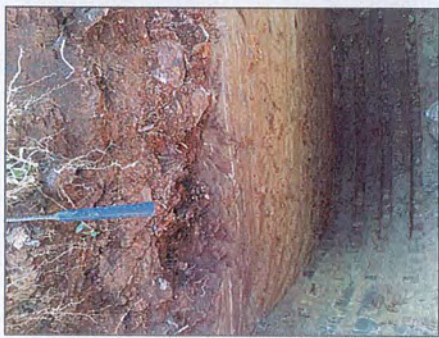
| <p>Test Pit no: TP35</p> <p>Note: Soil profile down to 2.00mbgl.</p> | <p>Test Pit no: TP35</p> <p>Note: Upper uncontrolled fill.</p> |

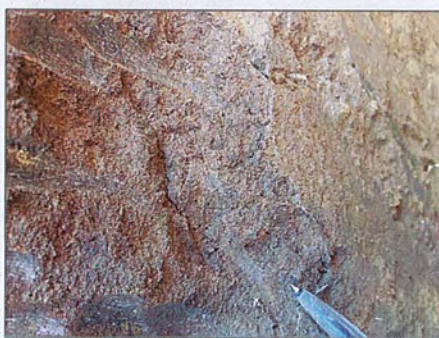
| <p>Test Pit no: TP35</p> <p>Note: Colluvium exhibiting open structure.</p> | <p>Test Pit no: TP35</p> <p>Note: Lower ferruginised pebble marker.</p> |

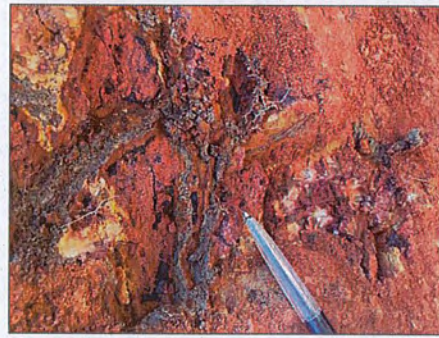
| <p>Test Pit no: TP36</p> <p>Note: Upper ferruginised residual shale..</p> | <p>Test Pit no: TP36</p> <p>Note: Lower residual shale.</p> |

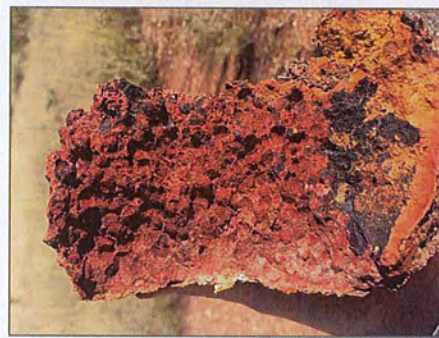
| <p>Test Pit no: TP36</p> <p>Note: Excavated ferruginised residual shale material.</p> | <p>Test Pit no: TP36</p> <p>Note: Excavated and tested lower residual shale.</p> |

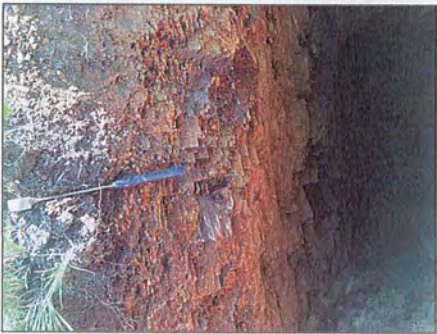
| <p>Test Pit no: TP37</p> <p>Note: Soil profile down to 3.00mbgl.</p> | <p>Test Pit no: TP37</p> <p>Note: Upper reworked shale material.</p> |

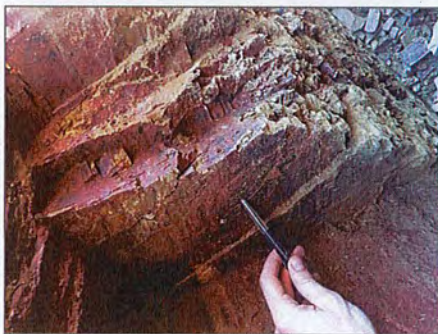
| <p>Test Pit no: TP37</p> <p>Note: Highly to completely weathered shale.</p> | <p>Test Pit no: TP37</p> <p>Note: Excavated and tested lower shale material.</p> |

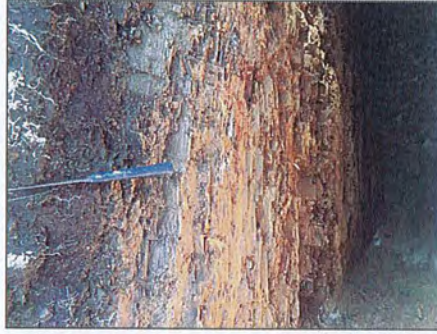
| <p>Test Pit no: TP38</p> <p>Note: Soil profile down to 3.00mbgl.</p> | <p>Test Pit no: TP38</p> <p>Note: Upper reworked shale material.</p> |

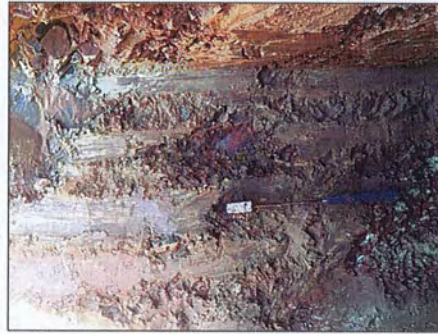
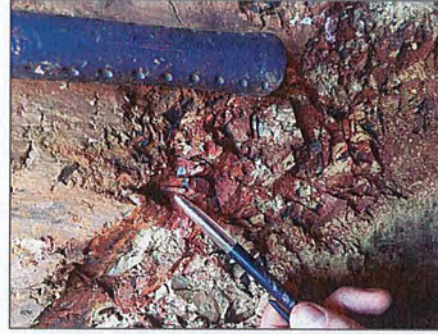
| <p>Test Pit no: TP38</p> <p>Note: Different degrees of weathering of shale layers.</p> | <p>Test Pit no: TP38</p> <p>Note: Different degrees of weathering of shale layers.</p> |

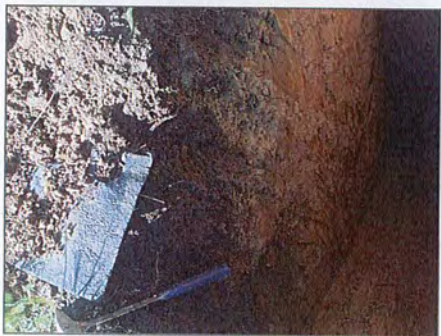
| <p>Test Pit no: TP39</p> <p>Note: Soil profile down to 3.10mbgl.</p> | <p>Test Pit no: TP39</p> <p>Note: Jointed structure exhibited residual shale.</p> |

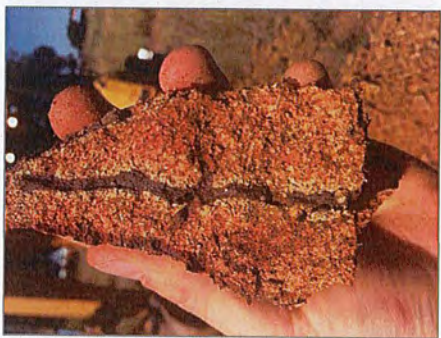
| <p>Test Pit no: TP39</p> <p>Note: Excavated lower residual shale.</p> | <p>Test Pit no: TP39</p> <p>Note: Excavated residual shale.</p> |

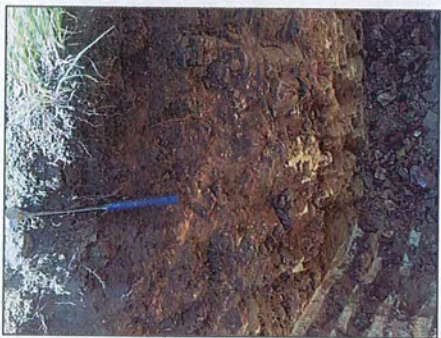
| <p>Test Pit no: TP40</p> <p>Note: Soil profile down to 1.77mbgl.</p> | <p>Test Pit no: TP40</p> <p>Note: Upper uncontrolled fill exhibiting open structure.</p> |

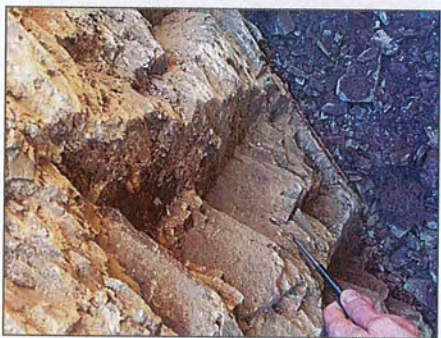
| <p>Test Pit no: TP40</p> <p>Note: Lower slightly to highly weathered shale.</p> | <p>Test Pit no: TP40</p> <p>Note: Excavated lower slightly to highly weathered shale material.</p> |

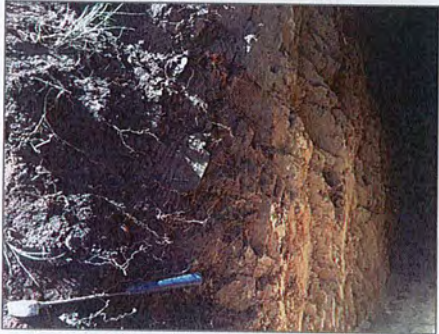
Test Pit no: TP41

Note: Soil profile to 3.10mbgl.

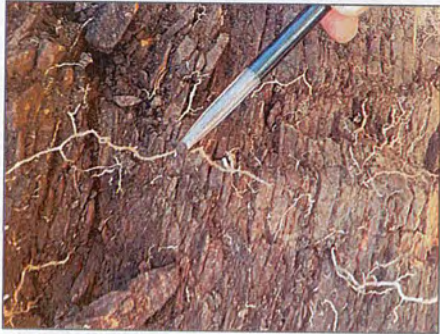
Test Pit no: TP41

Note: Completely to highly weathered shale.
