**SAICE 2010 Site Investigation Code of Practice Guided  
Tender Design or Basic Engineering Geotechnical Site  
Investigation Report for R/3, The Willows 340-JR, Region 6,  
Ward 86, Tshwane Metropolitan Municipality, Gauteng  
Province, South Africa**

**ROCKSOIL CONSULT PTY LTD**  
REG NO 2013/139402/07  
DIRECTOR: DIRK HERMAN WESSELS  
✉ **INFO@ROCKSOILCONSULT.CO.ZA**  
**SAGNASP: 400076/08**

**Client: Bvi Consulting Engineers (Pty) Ltd. Gauteng**

**Project number: RS18056**

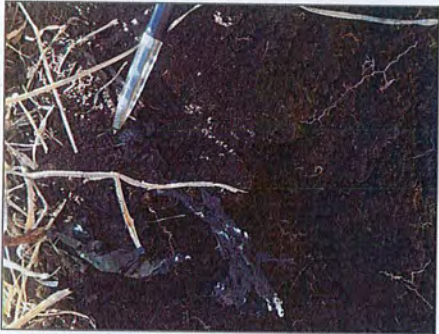
Test Pit no: TP41

Note: Upper uncontrolled fill.

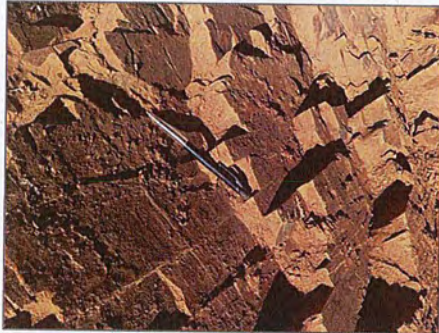
Test Pit no: TP41

Note: Lower highly weathered shale.

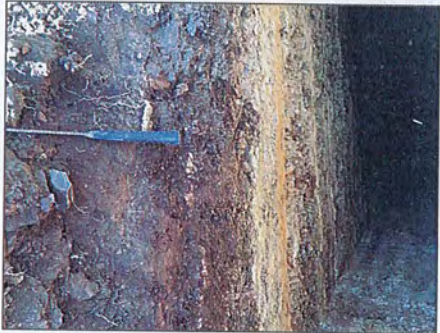
Test Pit no: TP42

Note: Soil profile down to 3.30mbgl.

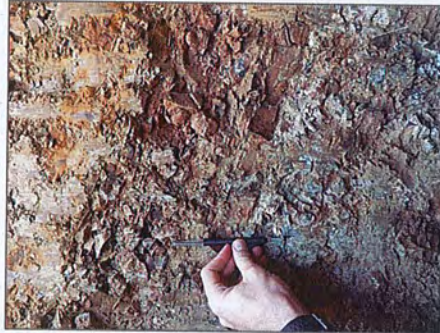
Test Pit no: TP42

Note: Different degrees of weathering in shale layers.

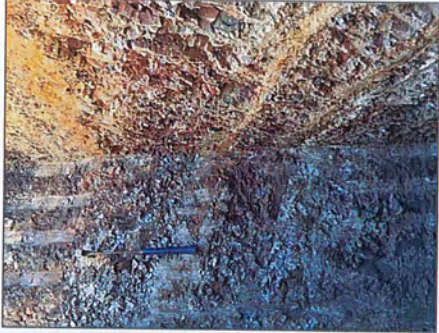
Test Pit no: TP42

Note: Different degrees of weathering in shale layers.

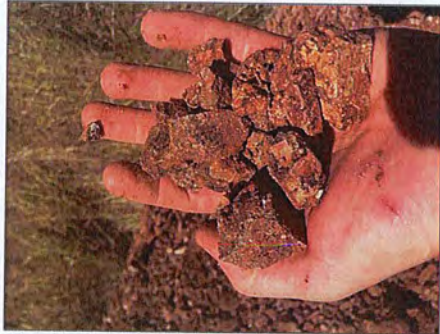
Test Pit no: TP42

Note: Excavated lower shale material.

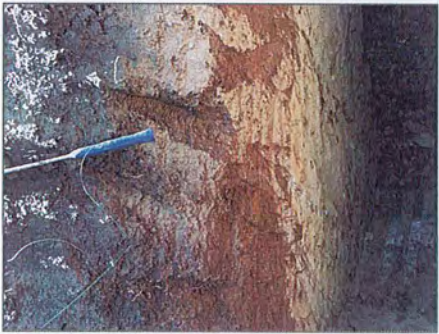
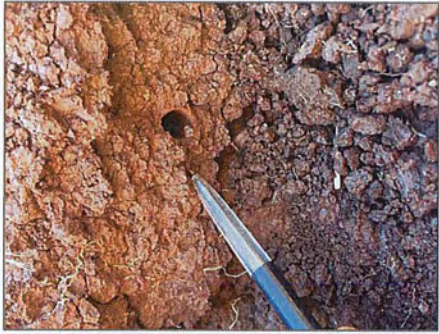
| <p>Test Pit no: TP43</p> <p>Note: Soil profile down to 3.10mbgl.</p> | <p>Test Pit no: TP43</p> <p>Note: Open structure exhibited by upper disturbed ground.</p> |

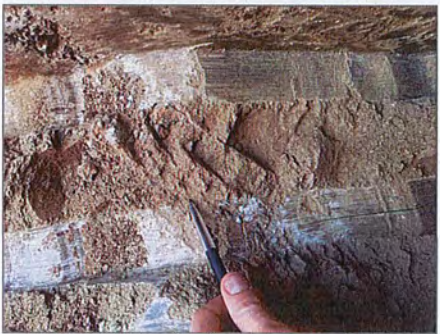
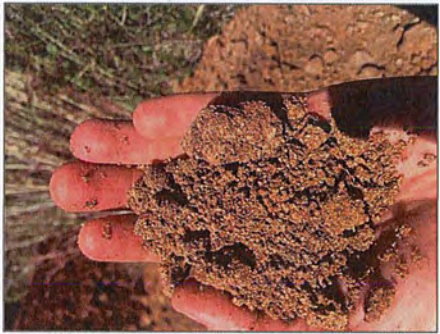
| <p>Test Pit no: TP43</p> <p>Note: Lower residual diabase.</p> | <p>Test Pit no: TP43</p> <p>Note: Excavated residual diabase.</p> |

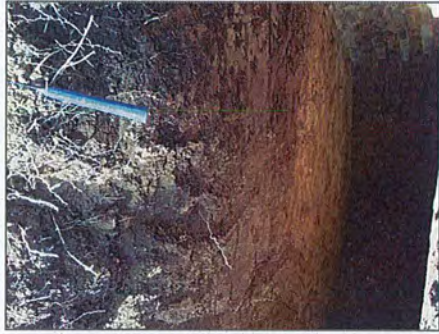
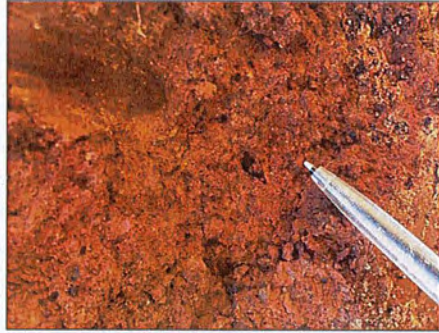
| <p>Test Pit no: TP44</p> <p>Note: Soil profile down to 3.00mbgl.</p> | <p>Test Pit no: TP44</p> <p>Note: Upper colluvium.</p> |

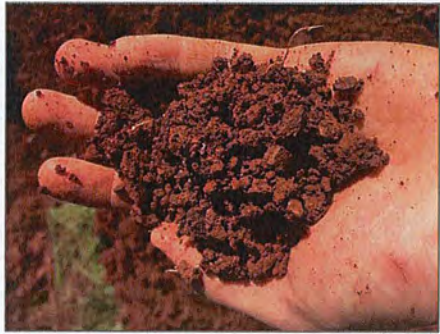
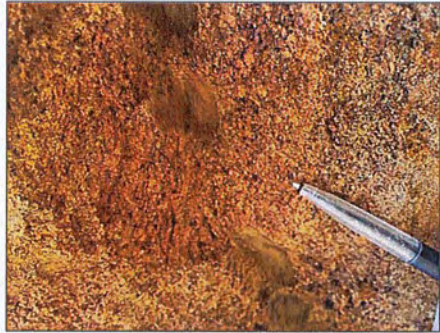
| <p>Test Pit no: TP44</p> <p>Note: Excavated and tested colluvium.</p> | <p>Test Pit no: TP44</p> <p>Note: Lower residual diabase.</p> |

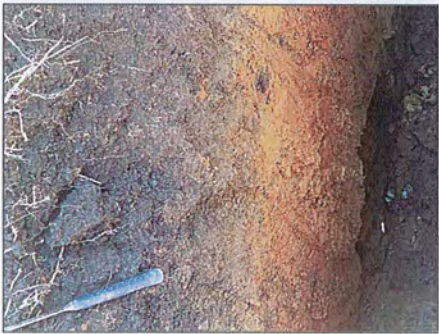
| <p>Test Pit no: TP45</p> <p>Note: Soil profile down to 3.10mbgl.</p> | <p>Test Pit no: TP45</p> <p>Note: Upper colluvium.</p> |

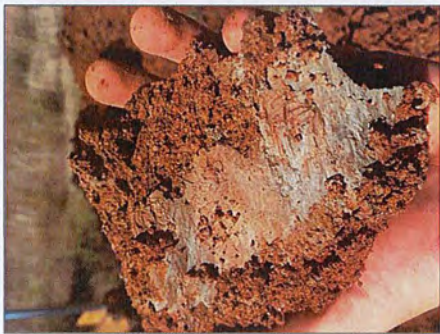
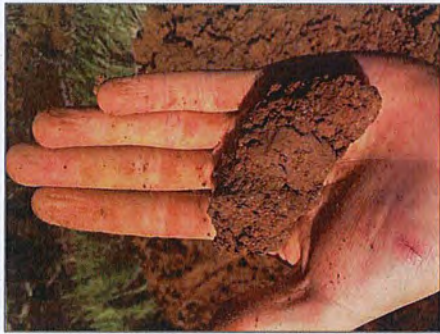
| <p>Test Pit no: TP45</p> <p>Note: Lower residual shale material.</p> | <p>Test Pit no: TP45</p> <p>Note: Plasticity exhibited by lower clay material.</p> |

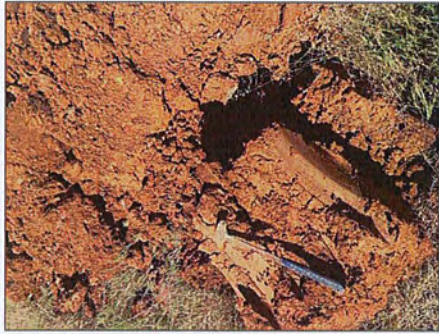
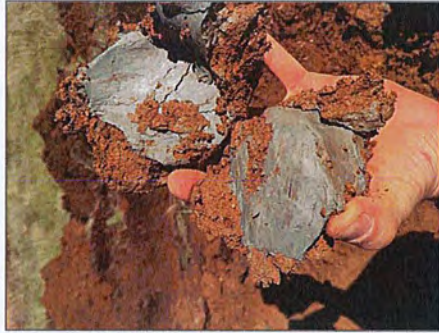
| <p>Test Pit no: TP46</p> <p>Note: Excavated lower residual shale material.</p> | <p>Test Pit no: TP46</p> <p>Note: Fissured structure exhibited by lower residual shale.</p> |

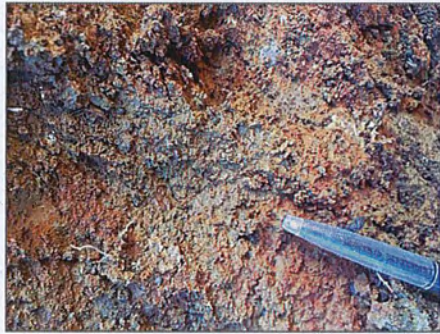
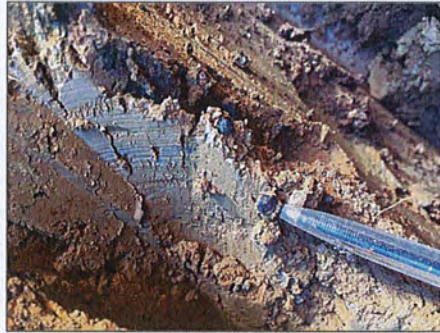
| <p>Test Pit no: TP46</p> <p>Note: Upper reworked residual shale.</p> | <p>Test Pit no: TP46</p> <p>Note: Ferricrete nodules present in residual shale.</p> |

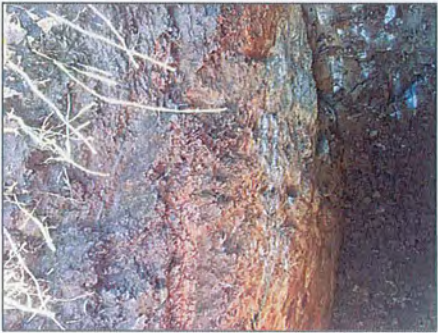
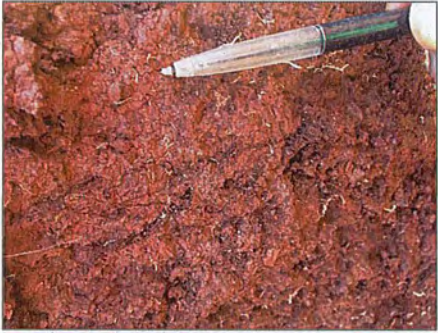
| <p>Test Pit no: TP47</p> <p>Note: Soil profile down to 2.50mbgl.</p> | <p>Test Pit no: TP47</p> <p>Note: Upper colluvium.</p> |

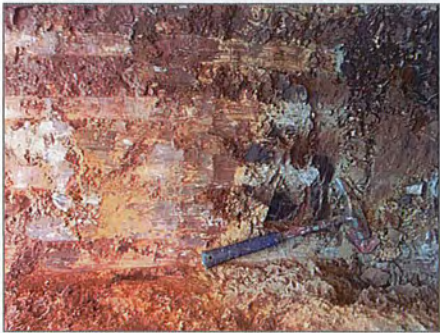
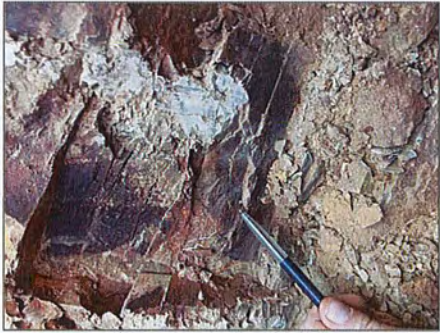
| <p>Test Pit no: TP47</p> <p>Note: Different degrees of weathering in shale layers.</p> | <p>Test Pit no: TP47</p> <p>Note: Lower highly weathered shale</p> |

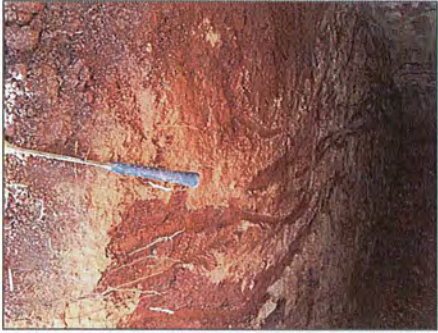
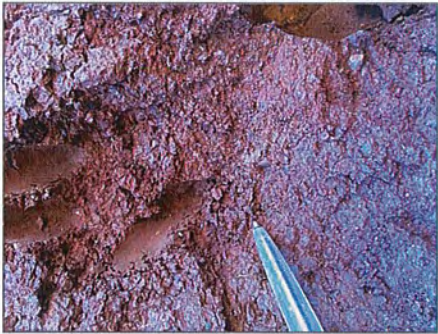
| <p>Test Pit no: TP48</p> <p>Note: Soil profile down to 3.00mbgl.</p> | <p>Test Pit no: TP48</p> <p>Note: Upper colluvium.</p> |

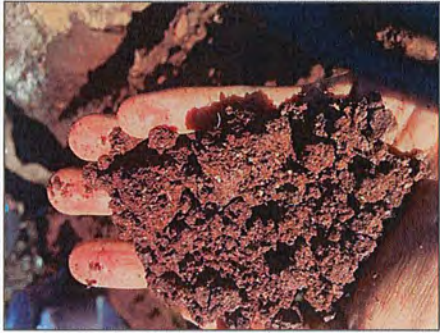
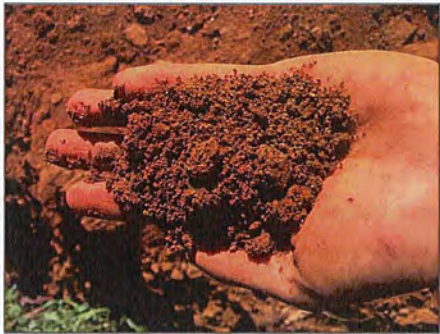
| <p>Test Pit no: TP48</p> <p>Note: Excavated and tested colluvium.</p> | <p>Test Pit no: TP48</p> <p>Note: Lower residual diabase.</p> |

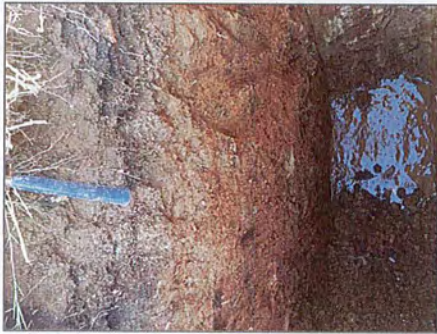
Test Pit no: TP49

Note: Soil profile down to 2.70mbgl.

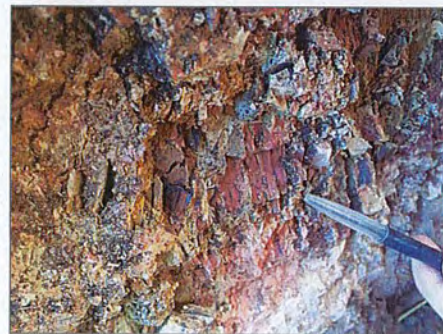
Test Pit no: TP49

Note: Reworked residual shale.

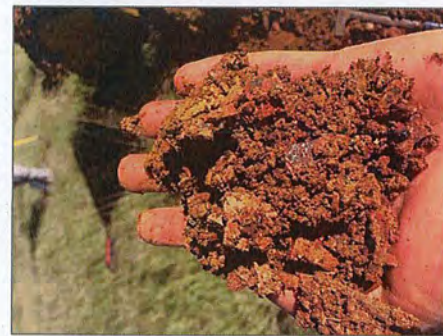
Test Pit no: TP49

Note: Lower residual shale.

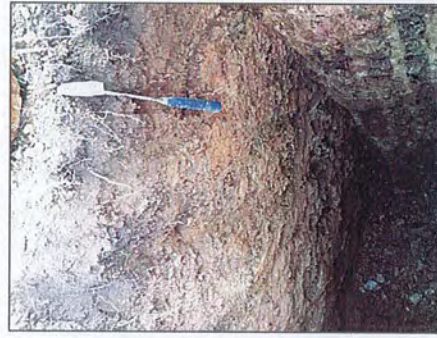
Test Pit no: TP50

Note: Soil profile down to 3.00mbgl.

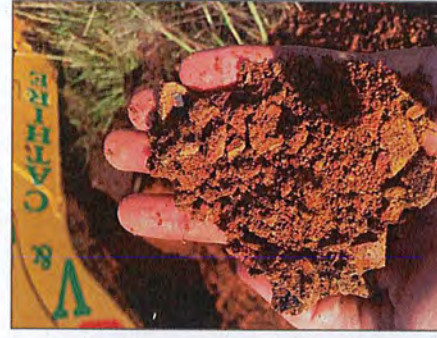
Test Pit no: TP50

Note: Upper reworked residual shale.

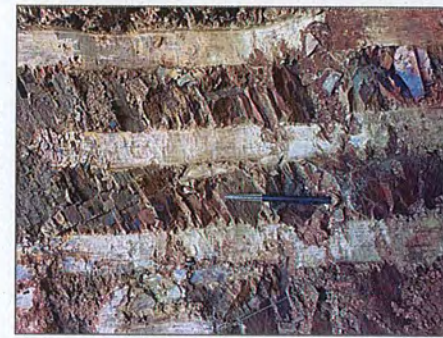
Test Pit no: TP50

Note: Lower slightly to highly weathered shale.

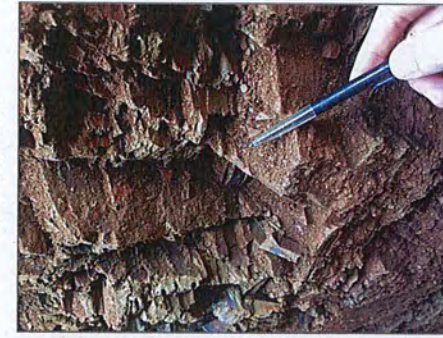
Test Pit no: TP50

Note: Lower slightly to highly weathered shale.

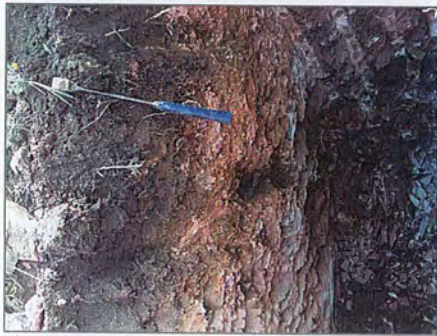
Test Pit no: TP51

Note: Soil profile down to 1.75mbgl

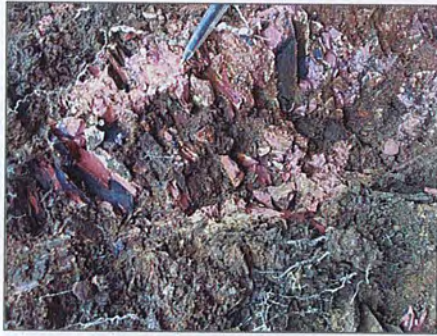
Test Pit no: TP51

Note: Upper reworked shale material.

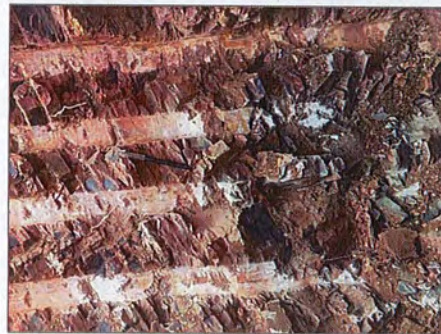
Test Pit no: TP51

Note: Lower shale material.

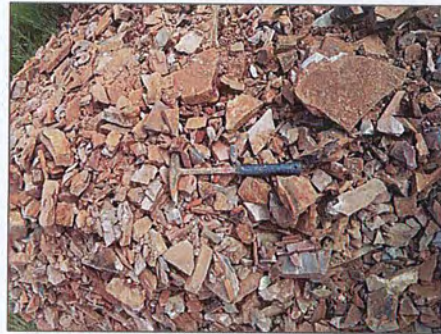
Test Pit no: TP51

Note: Excavated shale material.

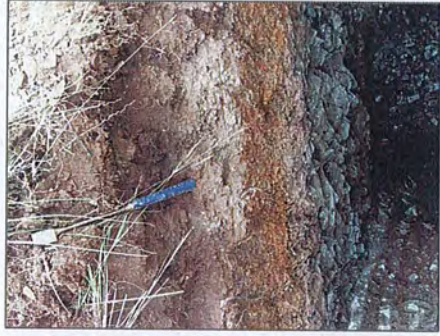
Test Pit no: TP52

Note: Soil profile down to 2.60mbgl.

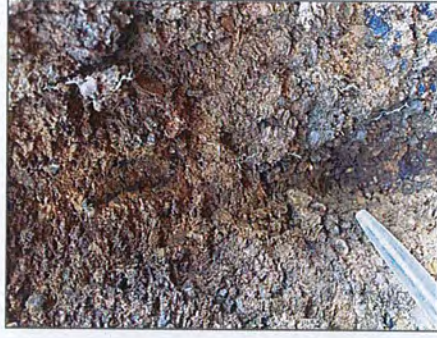
Test Pit no: TP52

Note: Upper colluvium.

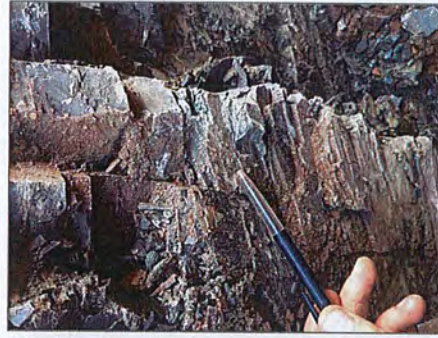
Test Pit no: TP52

Note: Lower highly weathered shale.

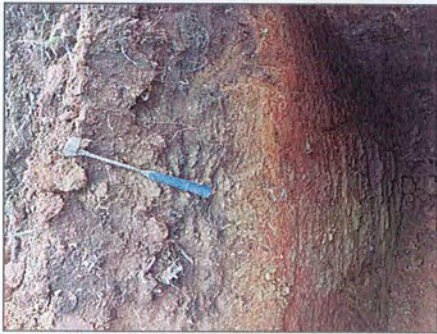
Test Pit no: TP53

Note: Soil profile down to 3.10m bgl.

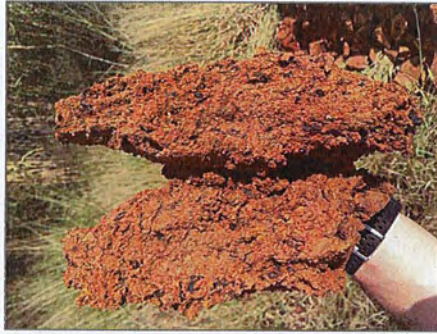
Test Pit no: TP53

Note: Excavated reworked residual shale material.

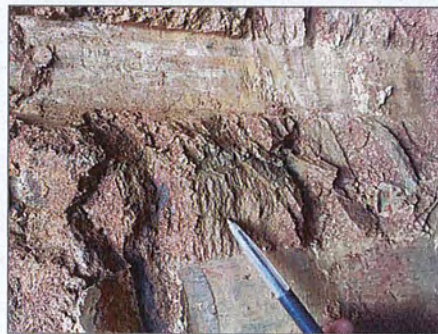
Test Pit no: TP53

Note: Lower completely weathered shale.

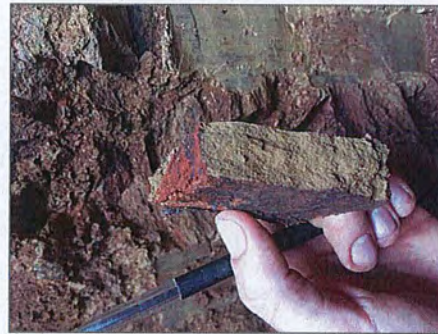
Test Pit no: TP53

Note: Lower completely weathered shale.

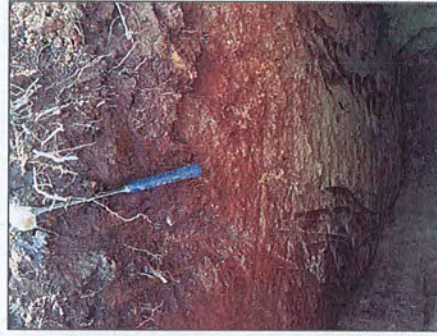
Test Pit no: TP54

Note: Soil profile down to 3.30m bgl.

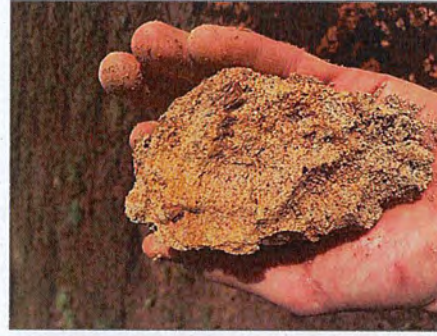
Test Pit no: TP54

Note: Excavated diabase material.

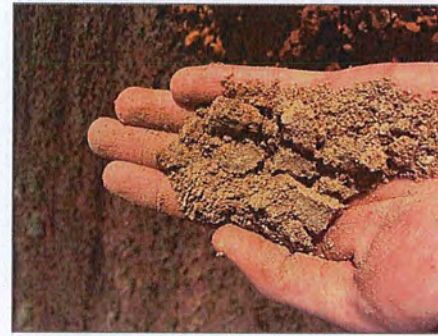
Test Pit no: TP54

Note: Excavated and tested residual diabase.

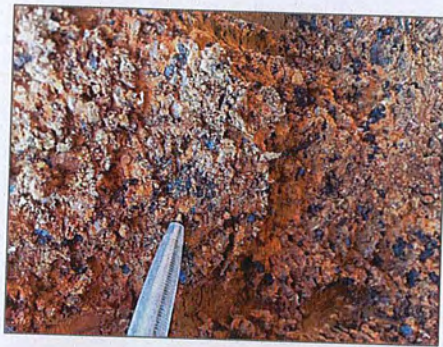
Test Pit no: TP55

Note: Upper colluvium.

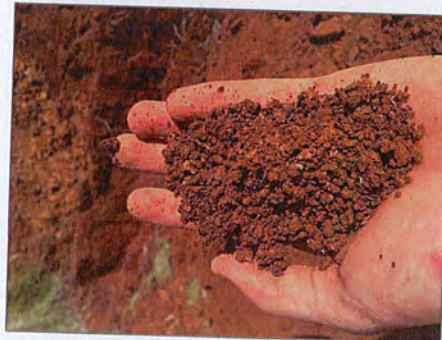
Test Pit no: TP55

Note: Excavated and tested colluvium.

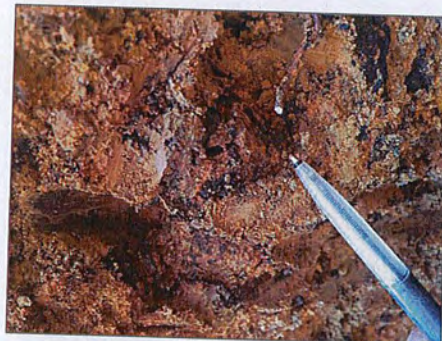
Test Pit no: TP55

Note: Lower residual diabase.

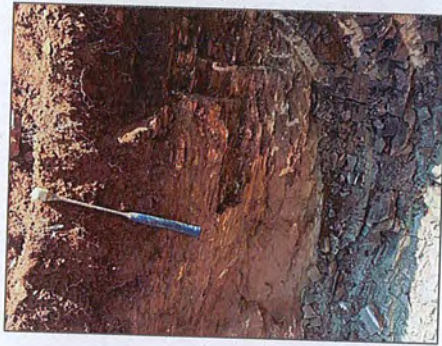
Test Pit no: TP56

Note: Soil profile down to 1.00mbgl.

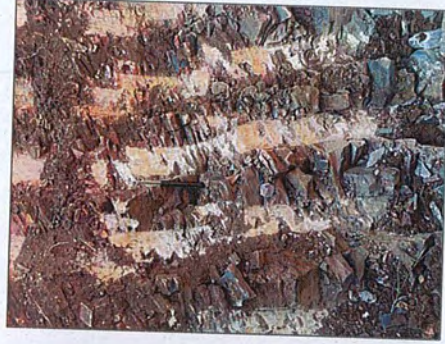
Test Pit no: TP56

Note: Lower shale material.

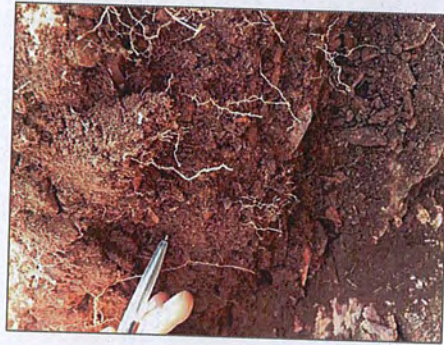
Test Pit no: TP56

Note: Upper reworked shale material.

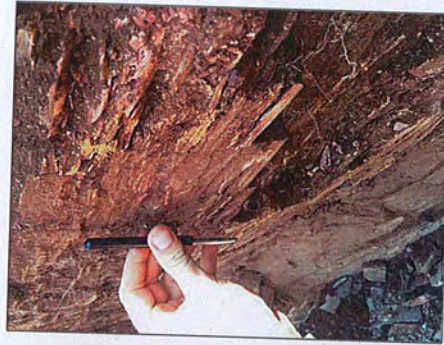
Test Pit no: TP56

Note: Lower shale material.

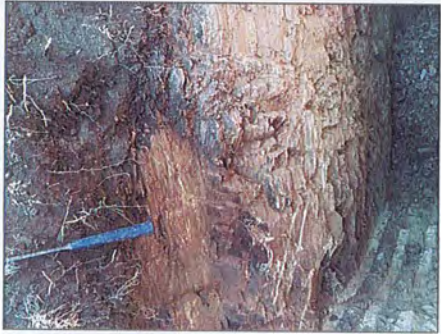
| <p>Test Pit no: TP57</p> <p>Note: Soil profile down to 2.70mbgl.</p> | <p>Test Pit no: TP57</p> <p>Note: Upper reworked residual shale.</p> |

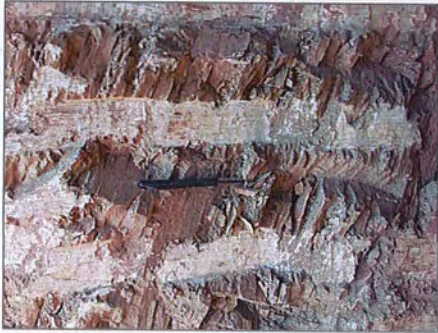
| <p>Test Pit no: TP57</p> <p>Note: Lower shale material.</p> | <p>Test Pit no: TP57</p> <p>Note: Excavated lower shale material.</p> |

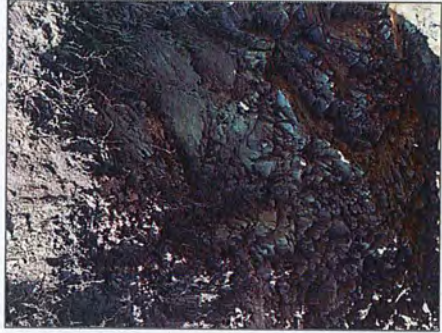
| <p>Test Pit no: TP58</p> <p>Note: Soil profile down to 3.30mbgl.</p> | <p>Test Pit no: TP58</p> <p>Note: Upper reworked residual shale..</p> |

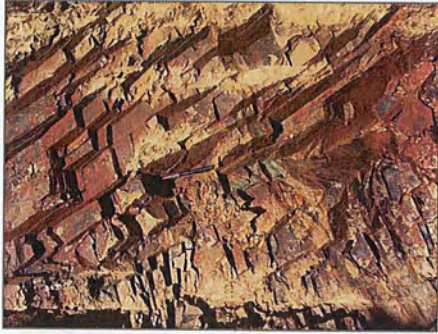
| <p>Test Pit no: TP58</p> <p>Note: Lower shale material.</p> | <p>Test Pit no: TP58</p> <p>Note: Lower shale material.</p> |

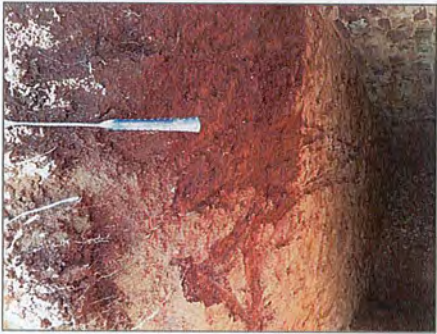
| <p>Test Pit no: TP59</p> <p>Note: Soil profile down to 3.30mbgl.</p> | <p>Test Pit no: TP59</p> <p>Note: Upper colluvium.</p> |

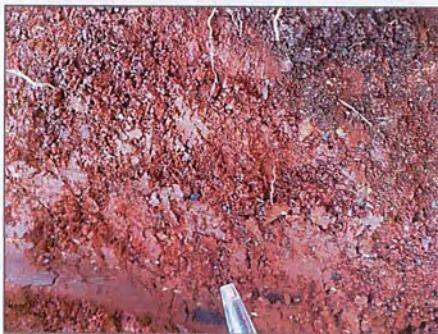
| <p>Test Pit no: TP59</p> <p>Note: Reworked residual shale.</p> | <p>Test Pit no: TP59</p> <p>Note: Lower residual diabase.</p> |

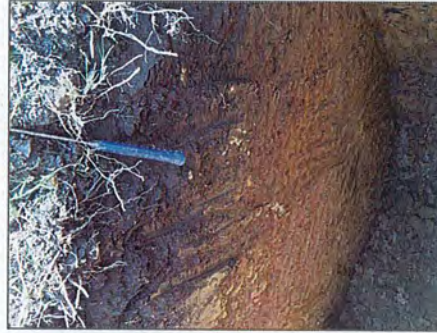
| <p>Test Pit no: TP60</p> <p>Note: Soil profile down to 3.00mbgl.</p> | <p>Test Pit no: TP60</p> <p>Note: Upper colluvium.</p> |

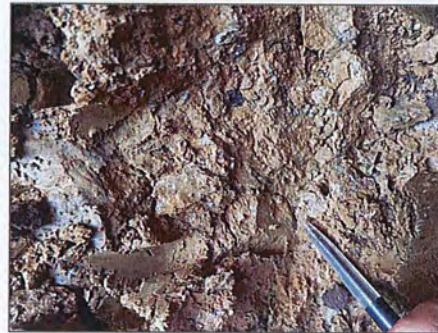
| <p>Test Pit no: TP60</p> <p>Note: Lower residual shale.</p> | <p>Test Pit no: TP60</p> <p>Note: Lower residual shale exhibiting fissured structure.</p> |

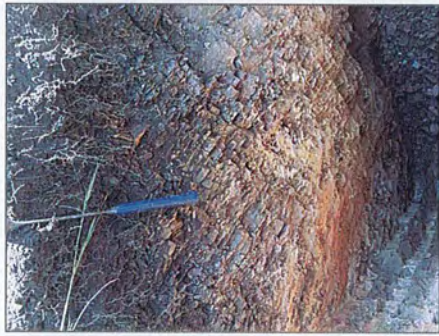
Test Pit no: TP61

Note: Soil profile down to 2.70mbgl.

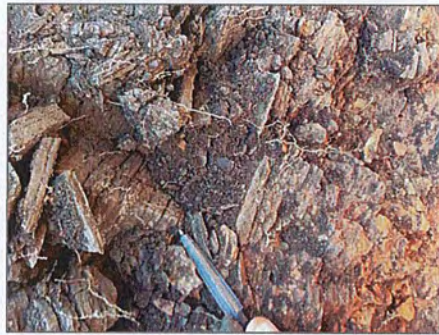
Test Pit no: TP61

Note: Upper reworked shale.

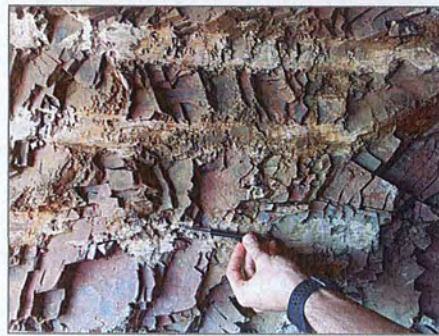
Test Pit no: TP61

Note: Lower shale with expected sidewall instabilities on north facing face.

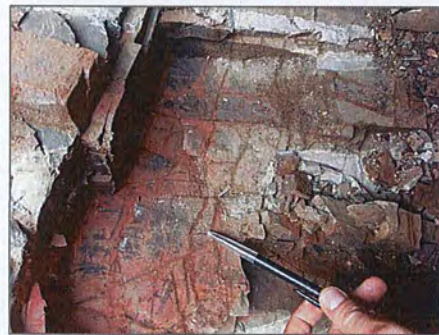
Test Pit no: TP61

Note: Lower shale material.

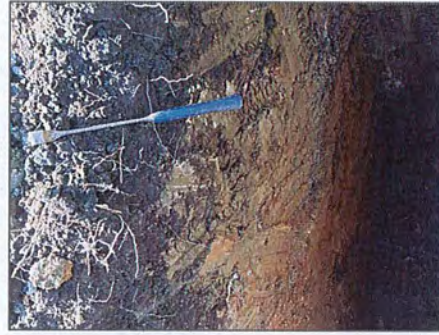
Test Pit no: TP62

Note: Soil profile down to 2.80mbgl.

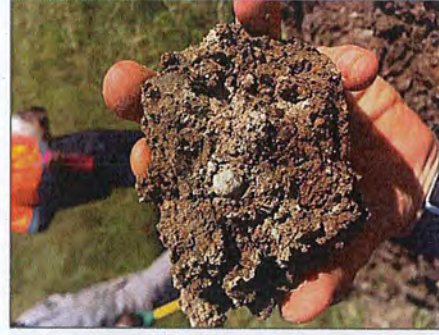
Test Pit no: TP62

Note: Excavated and tested alluvium.

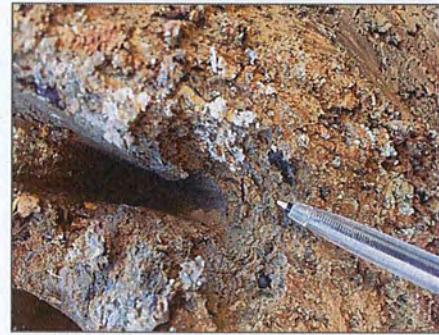
Test Pit no: TP62

Note: Residual shale.

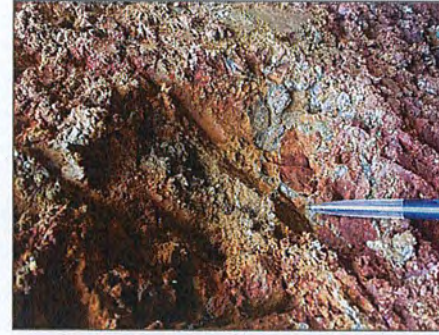
Test Pit no: TP62

Note: Lower shale material.

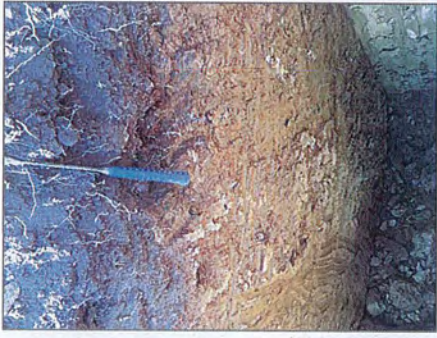
| <p>Test Pit no: TP63</p> <p>Note: Soil profile down to 3.10mbgl.</p> | <p>Test Pit no: TP63</p> <p>Note: Upper disturbed ground.</p> |

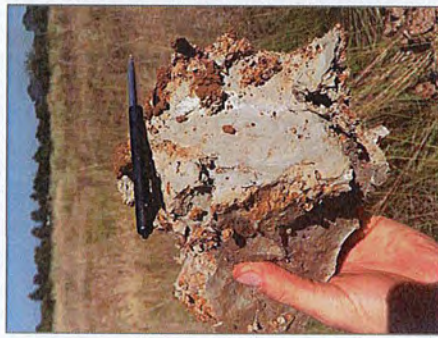
| <p>Test Pit no: TP63</p> <p>Note: Lower residual clay exhibiting fissured structure.</p> | <p>Test Pit no: TP63</p> <p>Note: Lower residual shale.</p> |

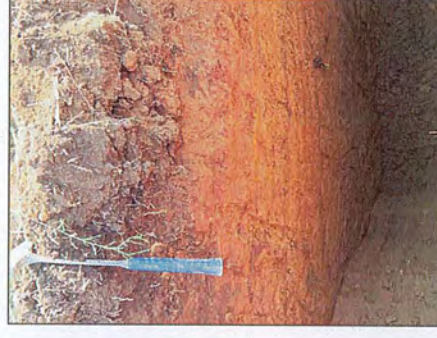
| <p>Test Pit no: TP64</p> <p>Note: Soil profile down to 3.10mbgl.</p> | <p>Test Pit no: TP64</p> <p>Note: Upper colluvium</p> |

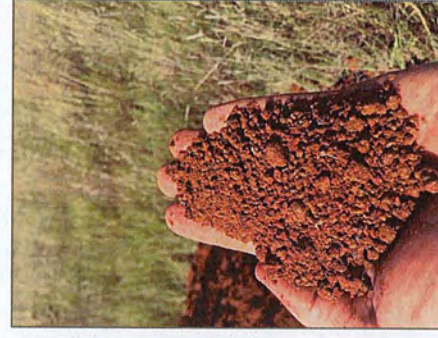
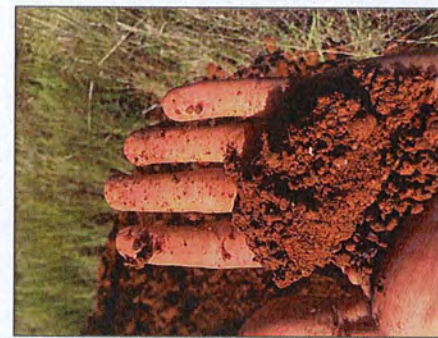
| <p>Test Pit no: TP64</p> <p>Note: Upper colluvium.</p> | <p>Test Pit no: TP64</p> <p>Note: Upper colluvium exhibiting plasticity.</p> |

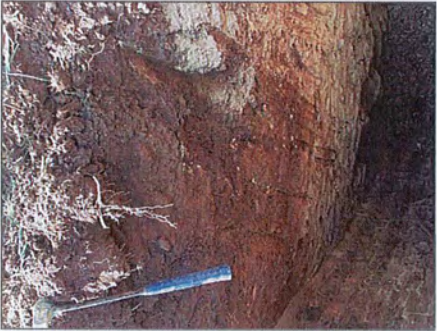
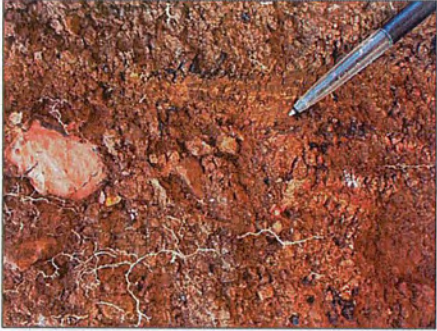
| <p>Test Pit no: TP65</p> <p>Note: Soil profile down to 3.00mbgl.</p> | <p>Test Pit no: TP65</p> <p>Note: Upper colluvium.</p> |

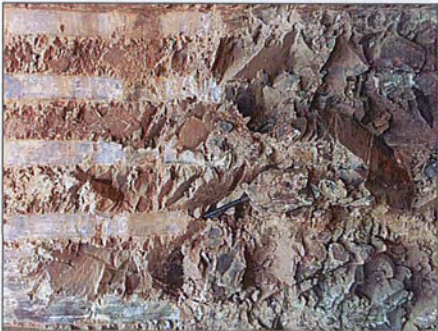
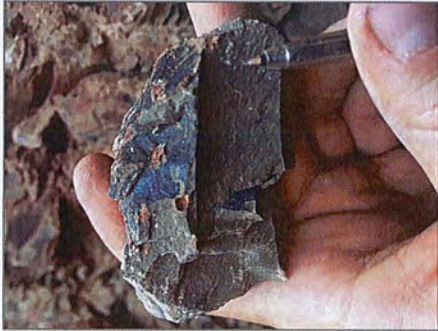
| <p>Test Pit no: TP65</p> <p>Note: Lower shale material.</p> | <p>Test Pit no: TP65</p> <p>Note: Lower shale material.</p> |

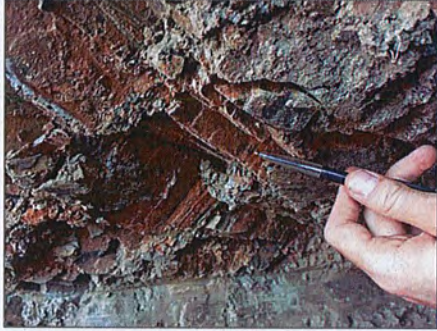
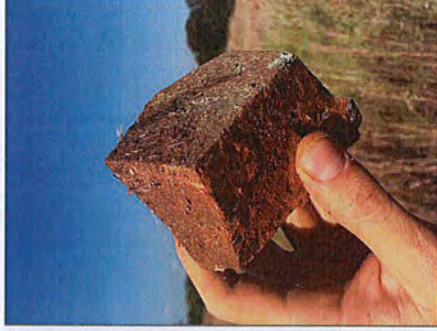
| <p>Test Pit no: TP66</p> <p>Note: Lower shale material.</p> | <p>Test Pit no: TP66</p> <p>Note: Lower shale material.</p> |

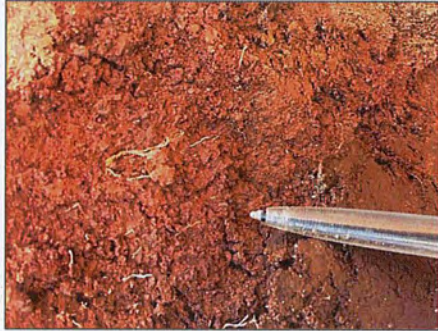
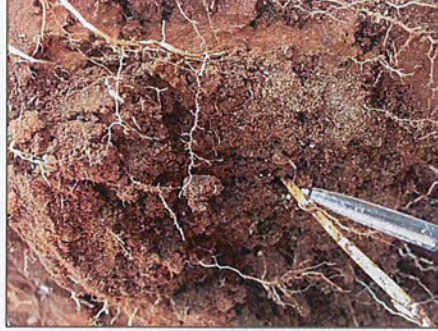
| <p>Test Pit no: TP66</p> <p>Note: Upper colluvium.</p> | <p>Test Pit no: TP66</p> <p>Note: Upper roots present.</p> |

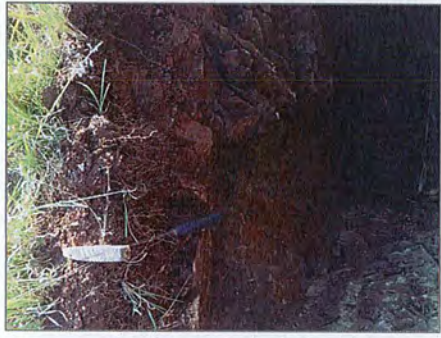
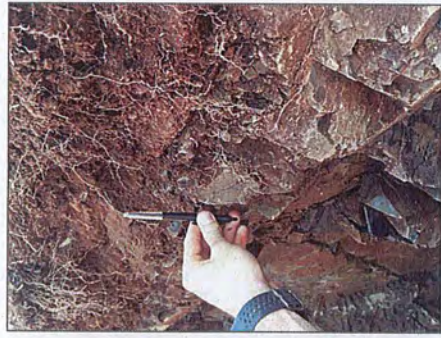
| <p>Test Pit no: TP67</p> <p>Note: Soil profile down to 1.80mbgl.</p> | <p>Test Pit no: TP67</p> <p>Note: Upper profile.</p> |

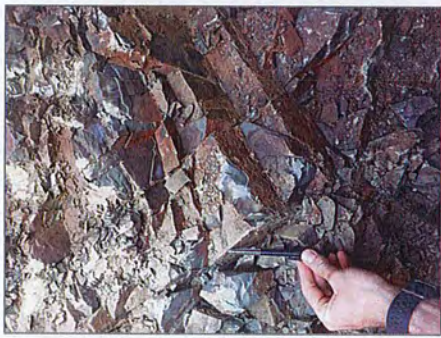
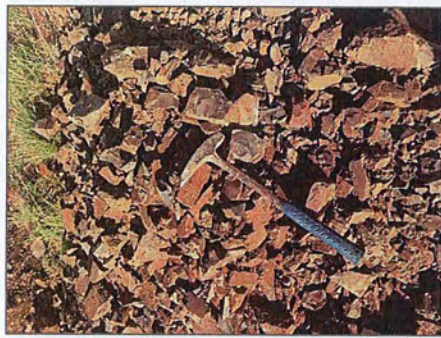
| <p>Test Pit no: TP67</p> <p>Note: Lower shale material.</p> | <p>Test Pit no: TP67</p> <p>Note: Excavated lower shale material.</p> |

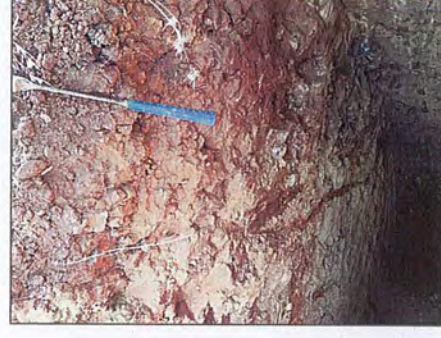
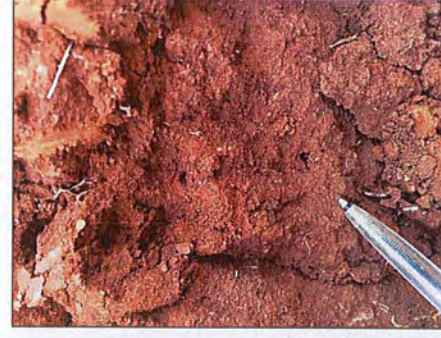
| <p>Test Pit no: TP68</p> <p>Note: Soil profile down to 3.10mbgl.</p> | <p>Test Pit no: TP68</p> <p>Note: Upper uncontrolled fill.</p> |

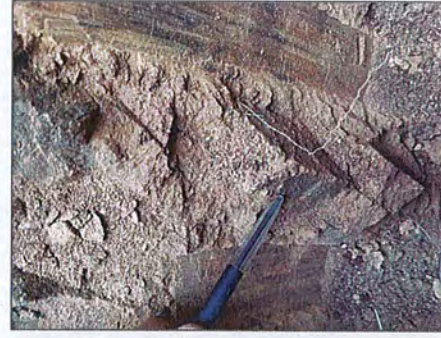
| <p>Test Pit no: TP68</p> <p>Note: Upper colluvium.</p> | <p>Test Pit no: TP68</p> <p>Note: Lower shale material.</p> |

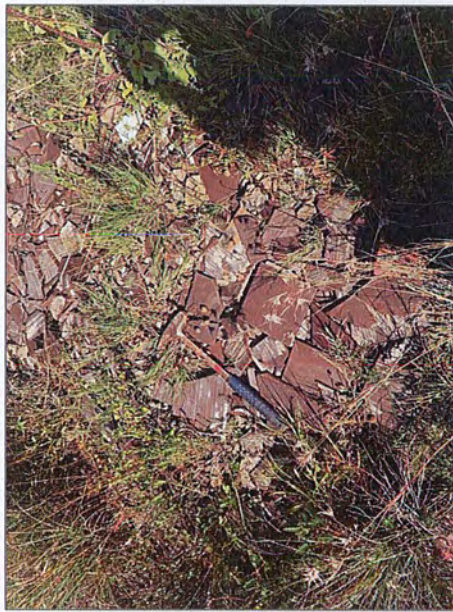
TP04

Note: Typical fill material found on site. Photograph taken south of TP04.

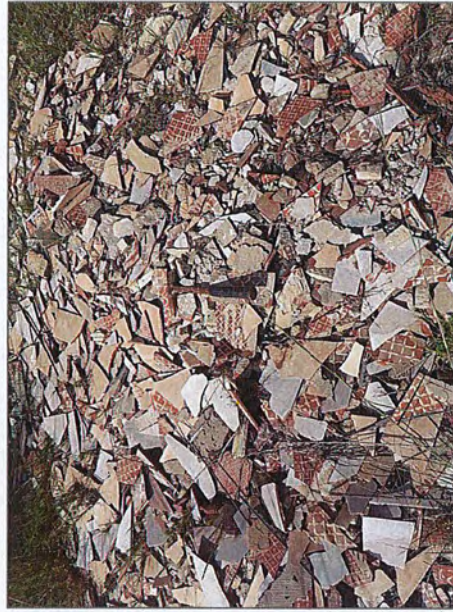
TP07

Note: Typical fill material found on site.

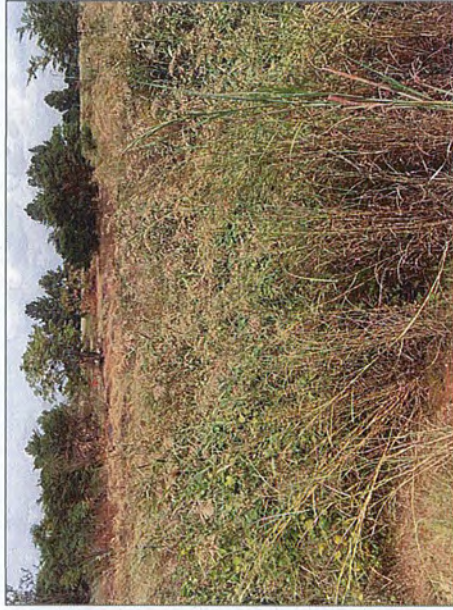
TP10

Note: Typical site conditions. Photograph taken of drainage ditch south of TP10.

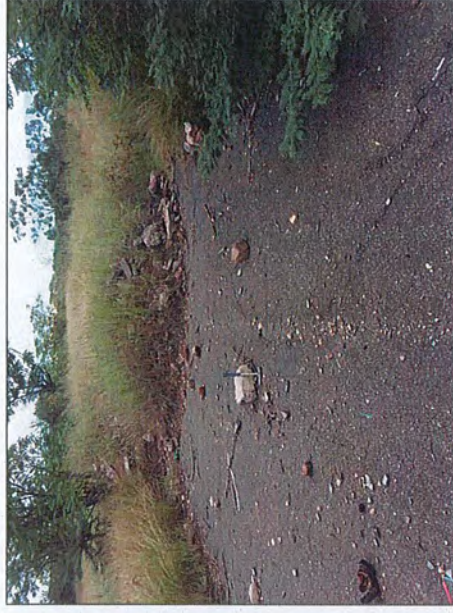
TP13

Note: Typical on site conditions around paved surface areas. Photograph taken north of TP13. Uncontrolled fill material associated with illegal dumping.

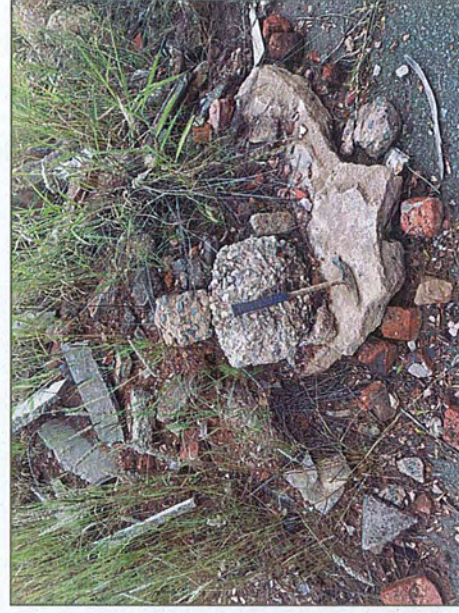
TP13

Note: Typical fill material found on site.

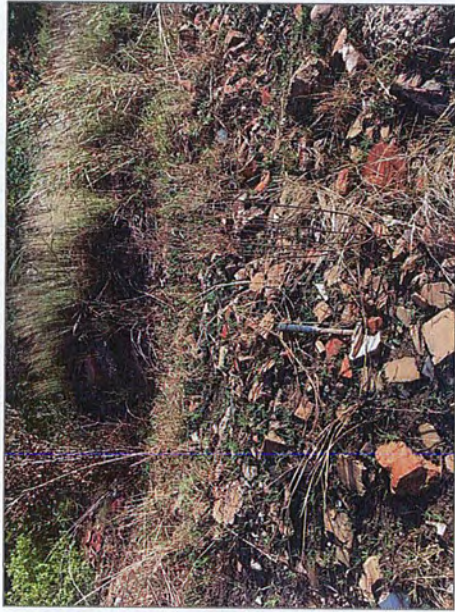
TP33

Note: Typical fill material found on site.

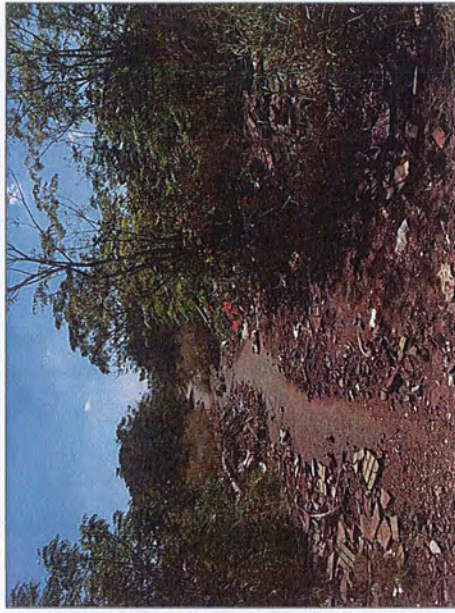
TP41

Note: Typical site conditions. Paved areas adjacently covered with thick superficial uncontrolled fill.

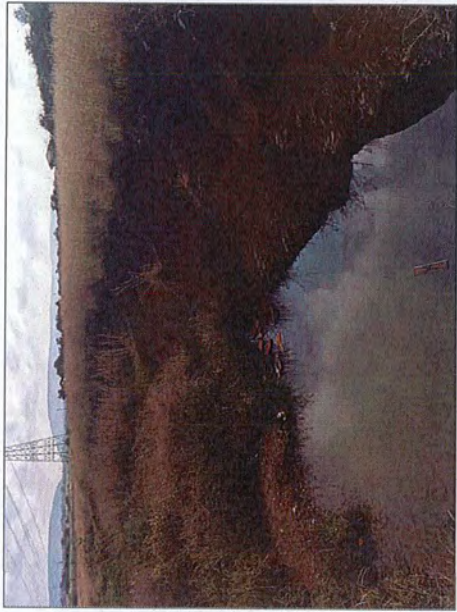
Dam

Note: Seepage water exist on site surrounding the central dam area. Photograph taken east of the dam in a southerly direction.

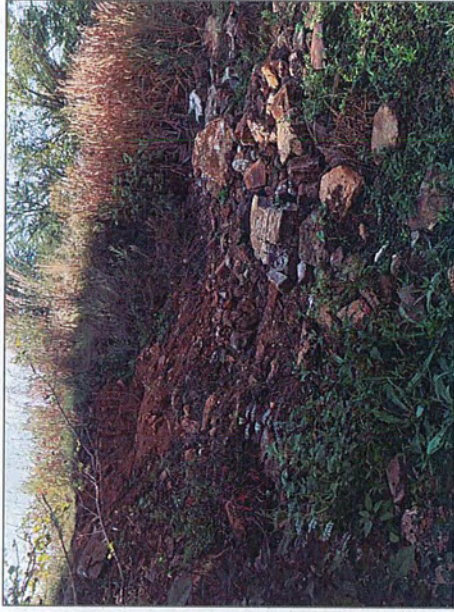
Dam

Note: Typical fill material within dam area.

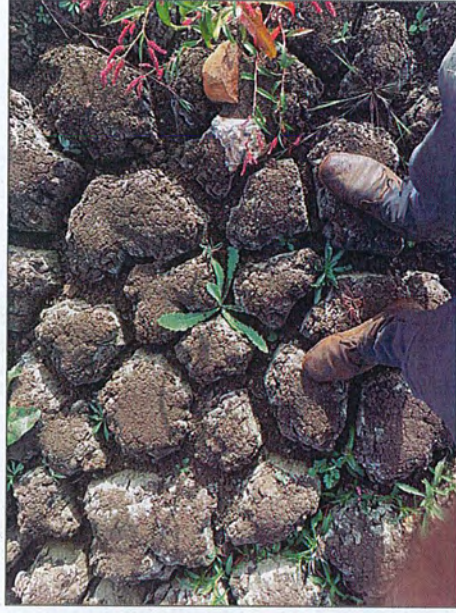
Note: Surface morphology typical of heaving. Photograph taken within the dam area.

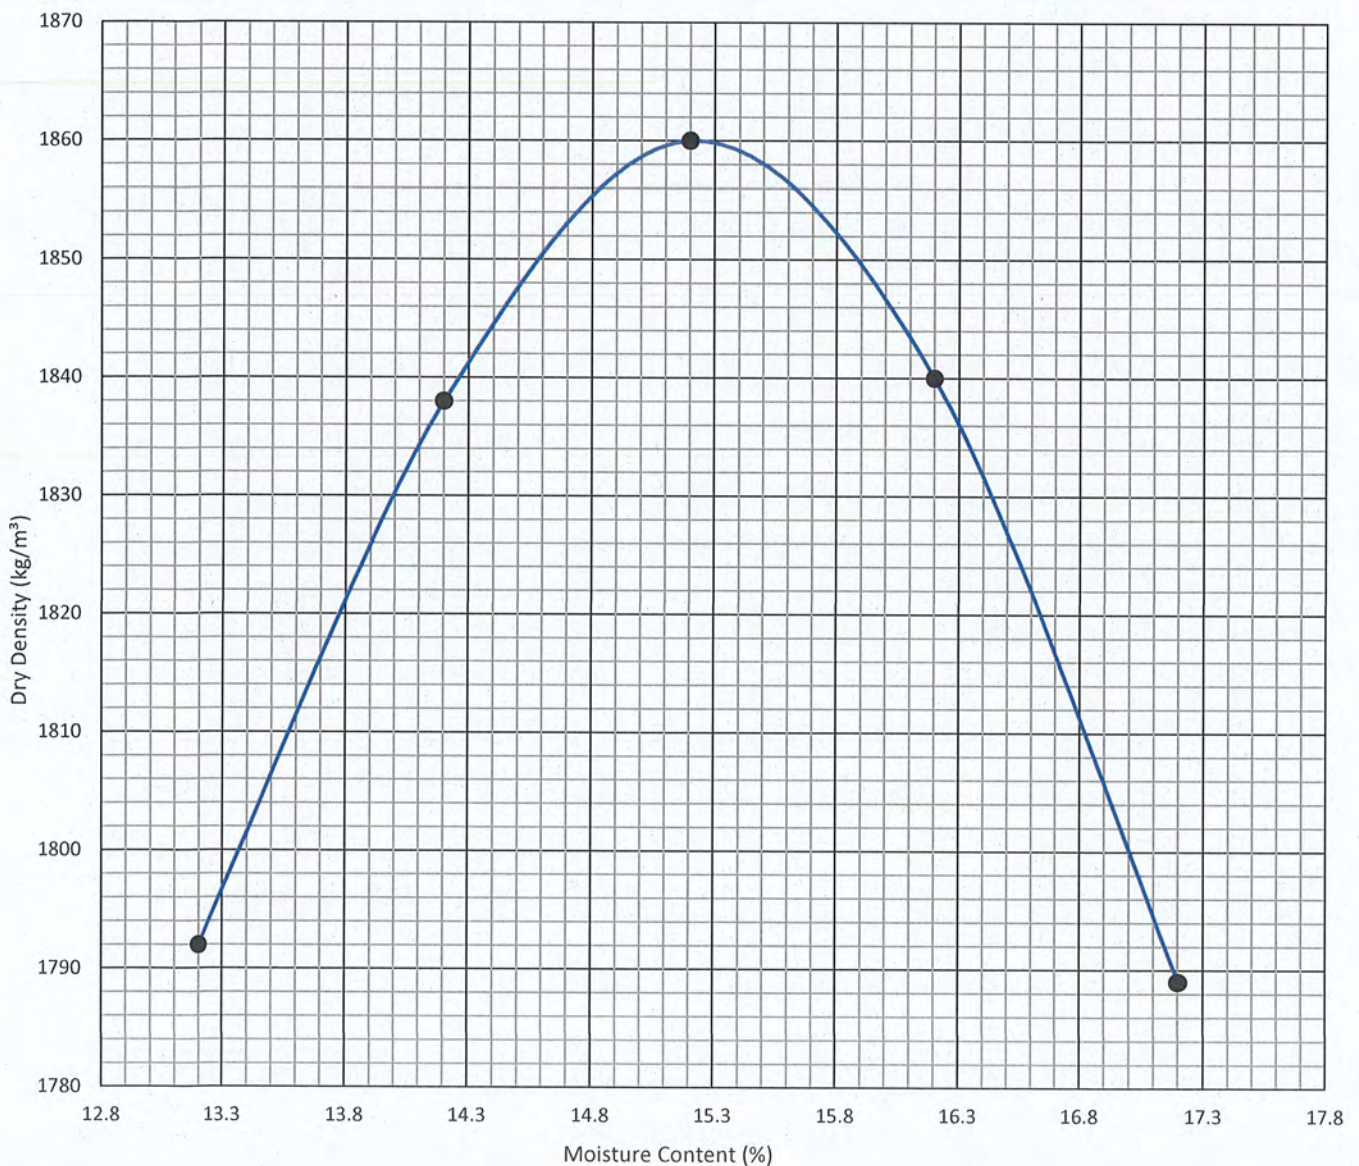
| Moisture Content (%): | 13.2 | 14.2 | 15.2 | 16.2 | 17.2 | | | |
| Dry Density (kg/m <sup>3</sup> ) | 1792 | 1838 | 1860 | 1840 | 1789 | | | |

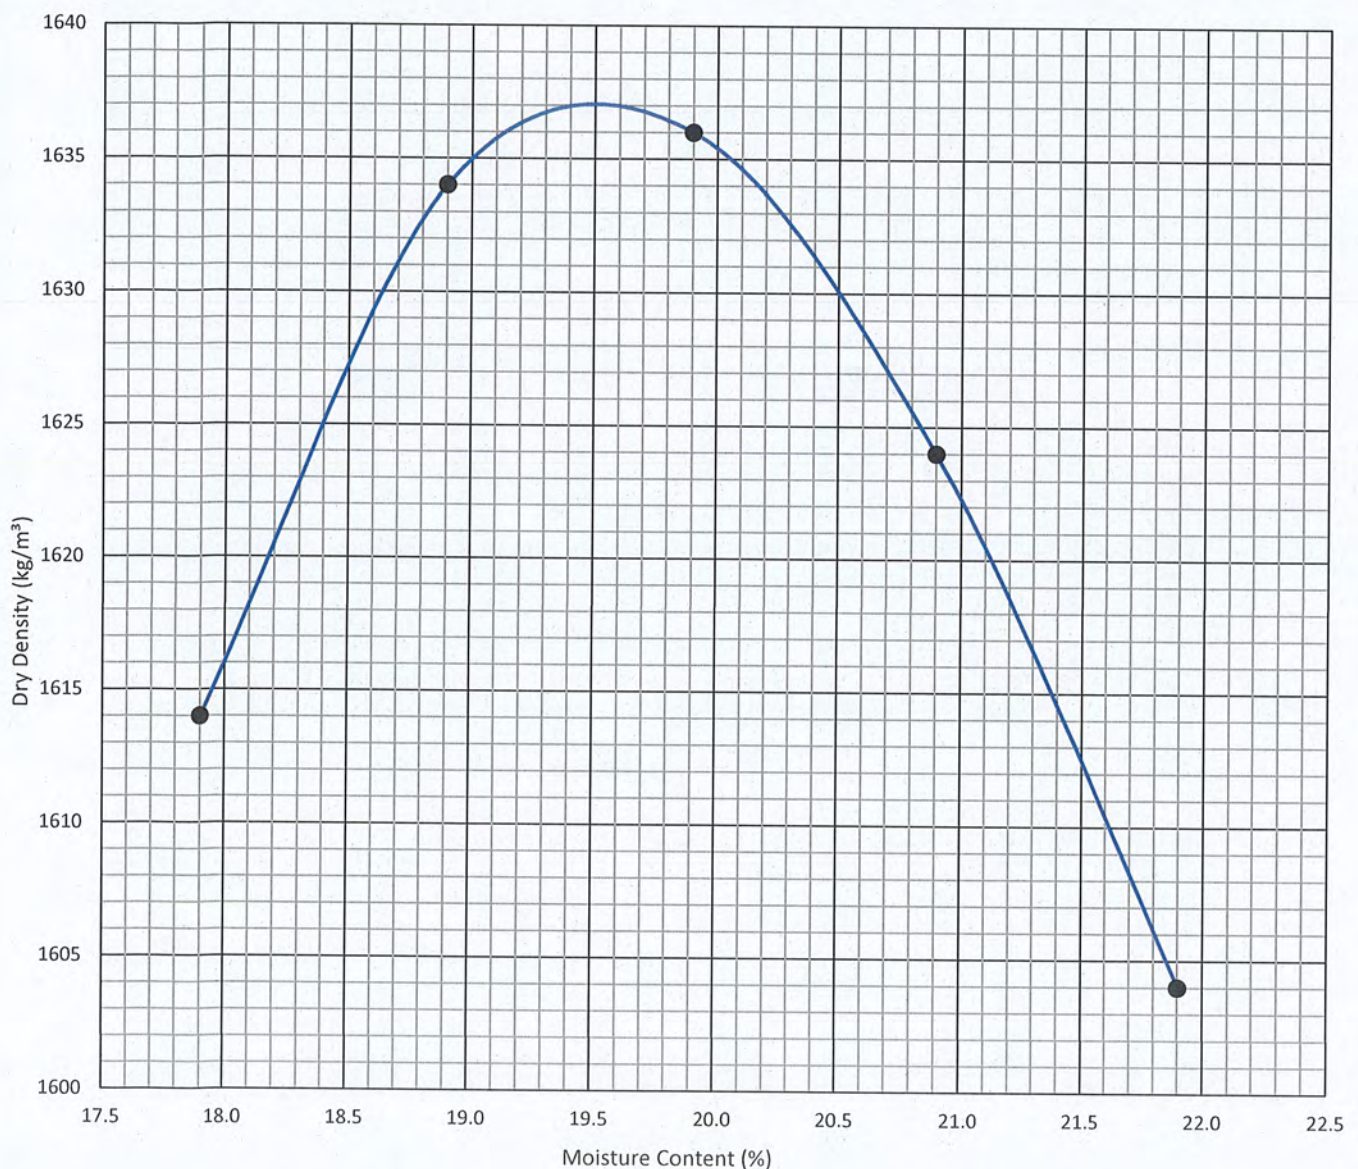
| Moisture Content (%): | 17.9 | 18.9 | 19.9 | 20.9 | 21.9 | | | |
| Dry Density (kg/m <sup>3</sup> ) | 1614 | 1634 | 1636 | 1624 | 1604 | | | |
